Effectiveness of CFRP Repair on Shear-Damaged Substandard Captive Columns

Keywords: Captive-Column, Repair, CFRP, Shear Failure, Reinforced Concrete.

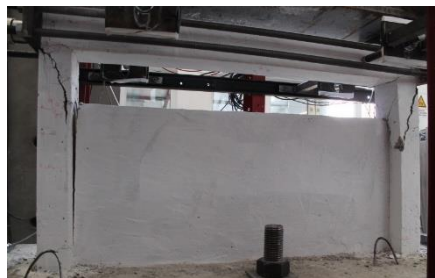
Fig. 2. Excessive shear cracks on the captive columns before repairing (CFRPE_02)

Before the application of CFRP, the corners of the columns and beam members were rounded with a radius of 10 mm to get smooth corners for the RC sections (Fig. 3(a)). To fill the large shear cracks, observed at the top of the columns, an epoxy acrylate resin called chemical anchorage was injected into the cracks (Fig. 3(b)). The next step of the repairing procedure is the application of repair mortar in the place of spalled concrete (Fig. 3(c)). A primer epoxy coat was used to provide an efficient adhesion

between the concrete and epoxy-based repair-anchorage mortar (Fig. 3(d)). The last step before the CFRP wrapping is to cover the repaired parts with an epoxy-based mortar for repairing the wide cracks and to provide a certain level of bonding between the repaired specimen and the CFRP sheets (Fig. 3(e)). Finally, the beam and the columns were wrapped by CFRP sheets with an epoxy resin before hardening the repair-anchorage mortar. The resin is used for establishing a connection between the CFRP sheets and the repair-anchorage mortar. Proper application of CFRP increases the flexural and shear capacity of the applied members (Fig. 3(f)).

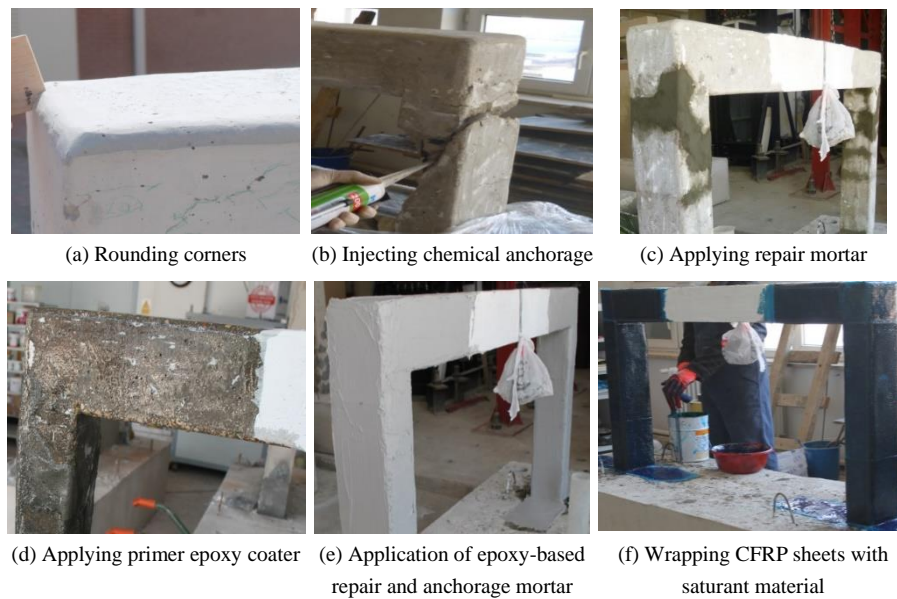
Fig.3. Repairing procedure for the damaged captive columns

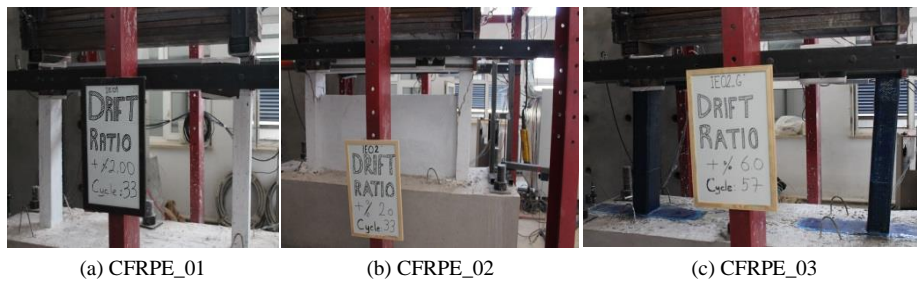
The first frame (CFRPE_01) was the reference frame without an infill wall (i.e., bare frame). Flexural behavior dominated the overall response of CFRPE_01 with the concentration of the flexural cracks mostly in the columns. Under constant axial load and reversed cyclic lateral displacement, a ductile behavior was observed with limited lateral load capacity compared to the lateral load capacities of the other specimens. CFRPE_02 was the second test specimen with captive column defects. Due to the increased strength and stiffness with the presence of the partial infill wall, the maximum lateral load was obtained as 28.2 kN, which is more than 2.5 times the lateral load capacity of the reference frame. Flexural cracks started to occur from the beginning of the experiment at both columns and joints. When the drift ratio reached 0.5%, shear cracks occurred in the captive columns. A sudden drop in the lateral capacity of the frame was observed at 1.0% drift ratio. Because of the severe damage in the captive columns in the succeeding drift ratios, the test for CFRPE_02 was ended at the displacement of 16 mm (2% drift ratio) due to safety concerns. After the damage occurred in CFRPE_02, it was repaired with CFRPs and retested as CFRPE_03, which is the repaired frame. The maximum lateral load of CFRPE_03 was recorded as 21.8 kN, which is almost twice the lateral load capacity of the reference specimen. A strength deterioration was observed specifically in the second cycle for the 4.4% drift ratio in the positive direction and in the first cycle of the 4.3% drift ratio in the negative direction. Although a ductile behavior was observed up to 4% drift ratio, a sharp decrement occurred in the strength. The damage pattern of all the test specimens at 2% drift ratio is shown in Fig. 4a-c. Nevertheless, only CFRPE_01 and CFRPE_03 specimens can displace up to 6% drift ratio. The views from both specimens are presented in Fig. 5a-c to demonstrate the damage pattern at the ultimate displacement.

Fig. 4. Damage pattern of the test specimens at 2% drift ratio

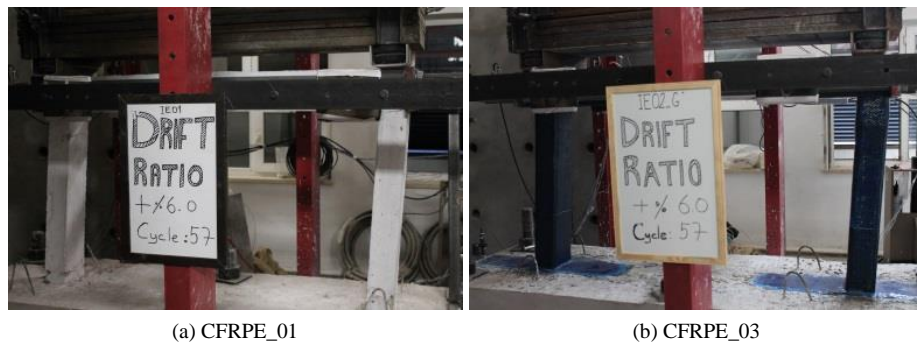
Fig. 5. Damage pattern of the test specimens at 6% drift ratio

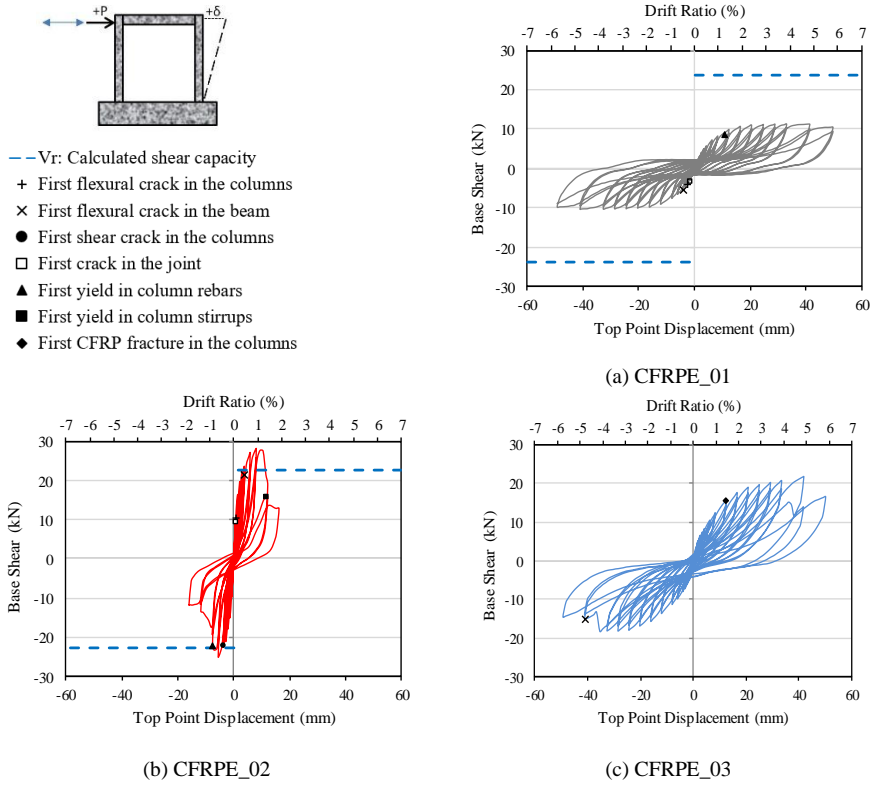
To determine the lateral load as well as the displacement capacity of the tested specimens, base shear force vs. top displacement graphs were plotted as given in Fig. 6a-c. The total shear capacity of the CFRPE_01 specimen columns is computed as 24 kN as

per TBEC (2018) [2]. As shown in Fig. 6(a), the columns did not reach their shear capacity and shear crack did not occur in CFRPE_01 specimen. The ultimate lateral load of CFRPE_02 was obtained as 28.2 kN and 25.0 kN in the positive and negative directions, respectively (Fig. 6b). A sudden drop in the lateral load was observed after attaining the peak lateral load values due to the shear damage at the captive columns. The calculated shear capacity is in good agreement with the lateral load capacity obtained from the test. Due to the reduction in the effective length of the captive column by the partial infill wall, the stiffness of the captive column increased considerably. As a result, the captive column attracted a shear demand exceeding its shear capacity. This phenomenon caused the shear failure of the columns, which violates the capacity design principles defined in TBEC (2018) [2]. Since the member cracks have remained under the CFRP layers, they could not be apparently seen in the CFRPE_03 specimen. After the 5% drift ratio, flexural cracks were observed at the middle part of the beam, which was not wrapped with CFRP. In Fig. 6(c), two sudden decrements of load values were monitored when the target drift ratio was 4% in the negative direction. However, the fracture of the CFRP sheets could not be apparently observed from the outer CFRP layers of the repaired specimen.

Fig. 6. Hysteretic loops of the specimens

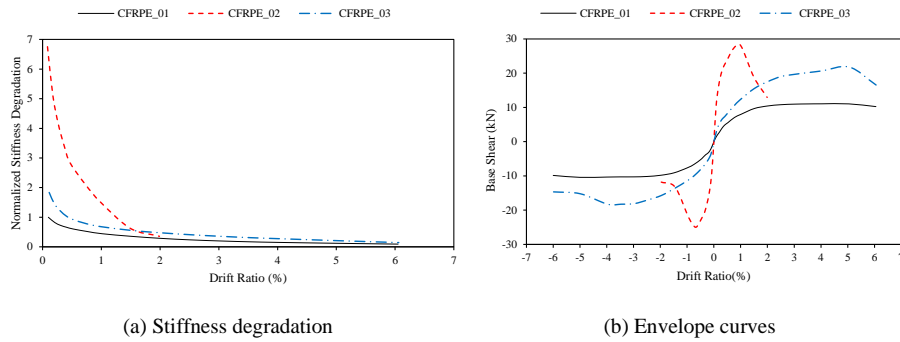
Envelope curves were constructed by combining the ultimate lateral load values at the target displacement points at the first peak of each cycle, as seen in Fig. 7b. It can be inferred that the strength of the repaired specimen (CFRPE_03) is greater than the one for reference specimen (CFRPE_01). However, if the results were compared with the second specimen (CFRPE_02), the repaired specimen had a 23% lower strength value because of the contribution of the partial infill wall in CFRPE_02. For CFRPE_01, CFRPE_02, and CFRPE_03 specimens, the ultimate strengths were observed at 4%, 1%, and 5% drift ratios, respectively. Except for the CFRPE_02 specimen, the other two specimens can be displaced up to the test displacement limits.

As the lateral displacement increased, the peak-to-peak lateral stiffness of the test specimens decreased very rapidly due to the formation of cracks and imposed plastic deformations (Fig. 7a). The peak-to-peak stiffness for each cycle was normalized with respect to the one for the reference specimen for the first cycle. CFRPE_03 specimen has a greater stiffness value than the reference specimen. However, after 2% drift ratio, both have very close stiffness values. Although the initial stiffness of the repaired specimen without infill wall is lower than the frame with partial infill wall, its stiffness is

almost twice the initial stiffness of the reference specimen. This implies that CFRP wrapping can improve the stiffness of the damaged RC frames even more than its original stiffness values for the bare frame.

Fig. 7. Comparison of response quantities
