Effectiveness of structural walls in improving the serviceability of a seismically-retrofitted RC building

Ahmet Şimşek¹ · Özgür Yurdakul² · Burak Duran³ · Onur Tunaboyu¹ · Suat Yıldırım⁴ · Özgür Avşar¹

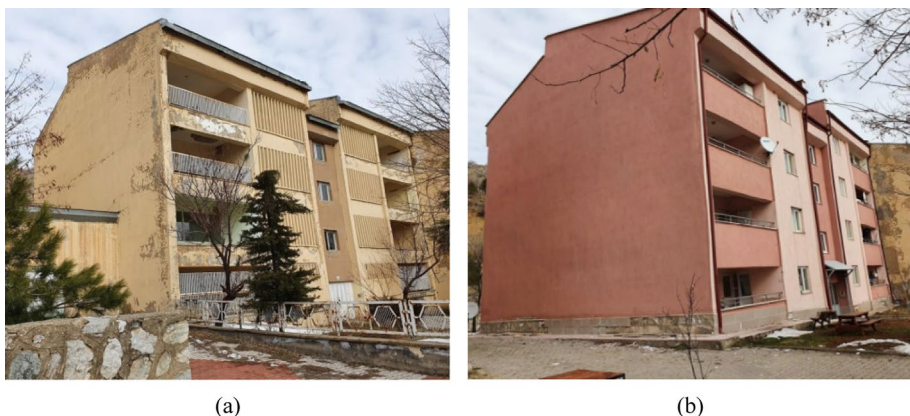
The identical buildings (see Fig. 3a, b) comprise the most common deficiencies of ordinary 3–5 story pre-1990s structures with substandard configuration. In most cases, the concrete strength was significantly below the code-specified values in these buildings due to in-situ mixed concrete with improper aggregate size, excessive water-cement ratio, and lack of curing (Çağatay 2005; Bal et al. 2008). The use of plain round bars, together with insufficient longitudinal and transverse reinforcement detailing, results from poor workmanship and an unaudited construction process. Such conflicts between seismic design code requirements and applications lead to non-conforming configurations. The geometric characteristics of the investigated buildings also reflect the common properties of 3–5-story pre-1990s substandard structures. A summary of Turkish building stock with the statistical outcomes and comparison with properties of the investigated buildings are presented in Table 3. Note that both retrofitted and non-retrofitted buildings have the same properties presented in the third column of Table 3.

Fig. 3 Investigated buildings **a** non-retrofitted **b** retrofitted

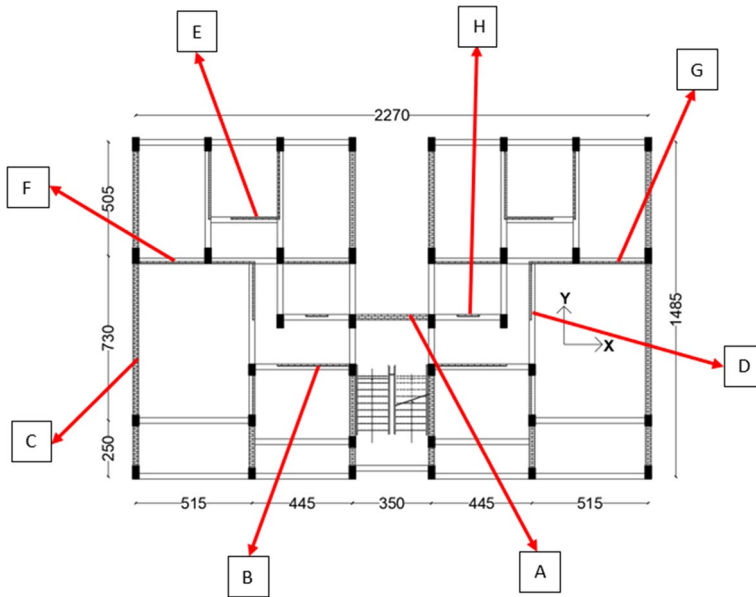
Figure 5 shows the location of severely damaged infill walls together with the counterpart infill walls of the retrofitted building on the structural floor plan. The indoor images in Fig. 6 present the side-by-side damage level of some nonstructural walls in the retrofitted and non-retrofitted buildings after the Sivrice-Elazığ earthquake. The photographic documentation shows the state of infill walls in the non-retrofitted building, which was subject to severe damage or even partial collapse. Due to heavy damage in the infill walls, the non-retrofitted building was not serviceable after the earthquake. In turn, no significant damage

Fig. 5 Position of the damaged infill walls in Fig. 6 on the floor plan

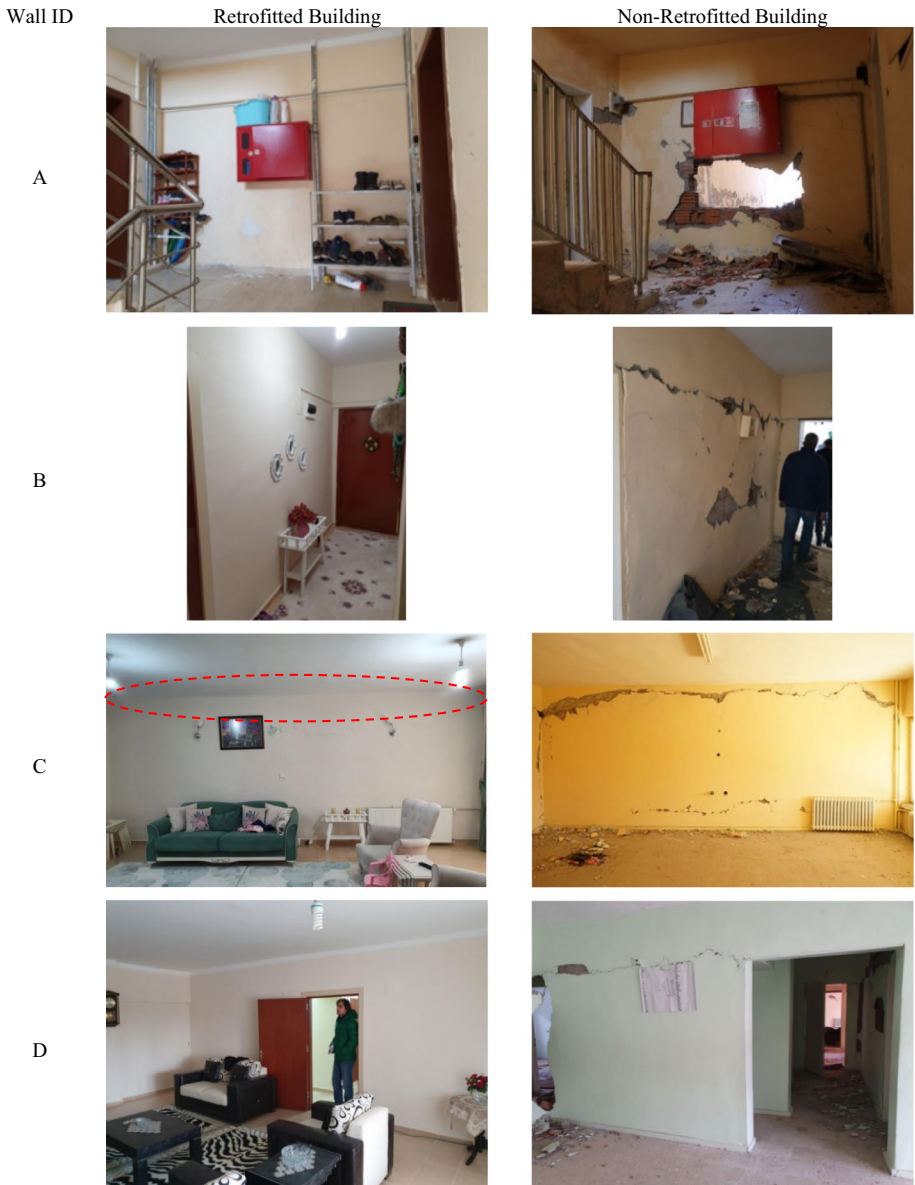
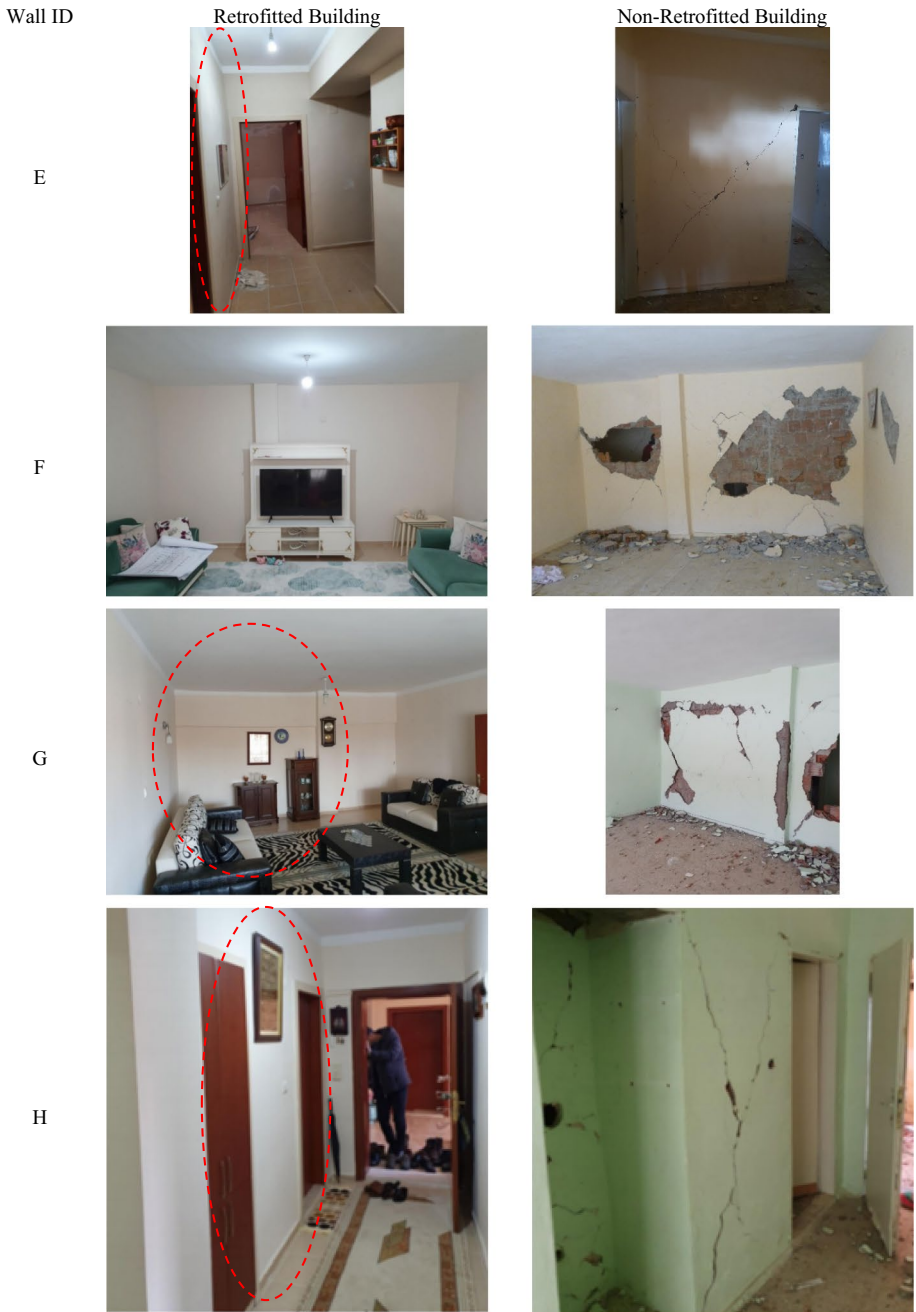
was detected in the retrofitted building except for the interface cracks between the existing structural components and the additional structural walls, which could be repaired easily after the earthquake without disrupting the serviceability of the building.

The infill wall damage in the non-retrofitted building was mainly concentrated in the x-direction (e.g., along the long plan dimension), as shown in Fig. 6 (see Fig. 5, Wall ID of A and B, and E to H for locations). The infill cracks in the X-pattern were the most

common crack type in the x-direction of the non-retrofitted building. The cracks in the infill walls along the y-direction (e.g., along the short plan dimension) of the non-retrofitted building in Fig. 6 (see Fig. 5, Wall ID of C and D for locations) were formed as interface cracks between the infill masonry and framing members. In the retrofitted building, no/slight cracks were observed for the same walls of A, B, E, and H in the x-direction. The y-direction cracks in retrofitted buildings formed as interface cracks with low intensity. These interface cracks are considered to be indicators of the load transfer from the existing structural system to the additional structural walls.

Fig. 6 Damage of the retrofitted and non-retrofitted buildings

demands in the retrofitted building. The imposed seismic damage on the infill walls of the non-retrofitted building presented in Fig. 6 can be explained by its relatively flexible nature compared to the retrofitted building. However, the mass participation ratio in each mode is reduced in the retrofitted building (Table 4). Therefore, higher modes of the retrofitted building are relatively more pronounced in the seismic response.

more damage in the x-direction infill walls of the non-retrofitted building (see Fig. 5-Wall ID of A and B, and E to H for locations, and Fig. 6 for damage level) also complied with the analysis results. Specifically, the increased drift demands in the non-retrofitted building, especially in the x-direction, explain the observed severe damage and partial collapse of the infill walls in the x-direction for the three considered ground motion records. The infill walls of A and B, and E to H, lying in the x-direction shown in Fig. 6, exhibited infill damage dominated by their in-plane behavior. As a result, mainly diagonal cracks were observed in these infill walls. However, the overall behavior of the infill walls of C and D, positioned in the y-direction of the non-retrofitted building, was generally governed by out-of-plane behavior. Therefore, horizontal cracks at the interface of the RC beams and the infill walls were mainly observed in the infill walls of C and D (Fig. 6).
