A few notes on research and restoration works carried out at the Faculty of Restoration, University of Pardubice within the frame of the EU project STONECORE.

Luboš Machačko¹, Blanka Kolinkeová, Dana Macounová, Karol Bayer

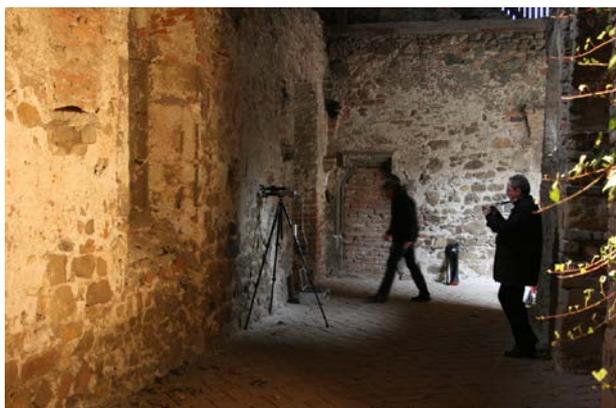
Figure 2 Former monastery Rosa Coeli, Czech Republic, testing of the consolidation effect, September 2010

Six commercial products intended for the consolidation of calcareous materials were tested (silicic acid esters, nanosols of $\text{Ca}(\text{OH})_2$ in alcohol and a consolidant based on colloidal silica) on render at the cloister of the monastery, Rosa Coeli. Penetration depth, consolidation of the surface, consolidation of the mass, water absorption and visual changes were observed using the “peeling test” method, micro-drilling resistance measurement and water uptake measurement. Based on the results of the tests CaLoSiL E 25 was chosen as most

appropriate agent for the structural consolidation of the mortars.

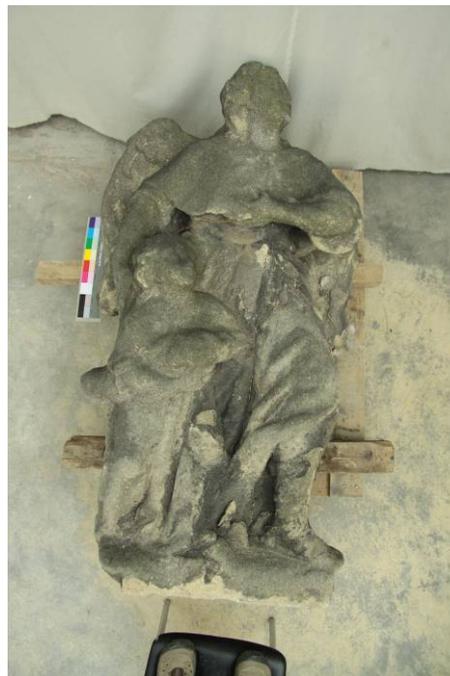
The main phenomena of damage based on the results of the preliminary investigation were:

- 1) the vast loss of the authentic surface of the statue caused by the sulphatisation of CaCO_3 , the destruction of CaCO_3 bond by CaSO_4 and, locally, by the formation of gypsum crusts;
- 2) crumbling and the considerable loss of stone mass caused by improper hard fillings in the concrete used during previous restoration treatments;
- 3) microbiological attack (green algae).

Figure 3 Statue of an Angel, before the treatment, September 2010

The task of the conservation process was to stabilize the statue through structural consolidation, grouting and the fixing of the borders of the damaged limestone parts using materials compatible with the original stone. The conservation treatment involved also the removal of dust and dirt, the reduction of gypsum crusts, the filling in of certain parts with an appropriate filler (chosen after laboratory testing), colour retouching and the placing of the statue back in its original location.

All consolidation treatments (structural consolidation, grouting, fixing) were done using nanosol-based consolidants from the CaLoSiL family.

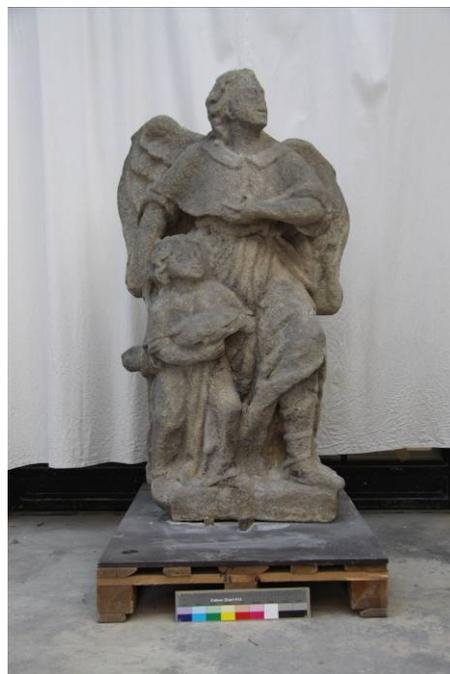
Figure 4 Statue of an Angel, after the treatment, April 2011
