DIPLOMOVÁ PRÁCE

University of Pardubice

Faculty of Restoration

Tests on sustainability of consolidation treatments with CaLoSil®
nanosuspensions on plaster reference samples

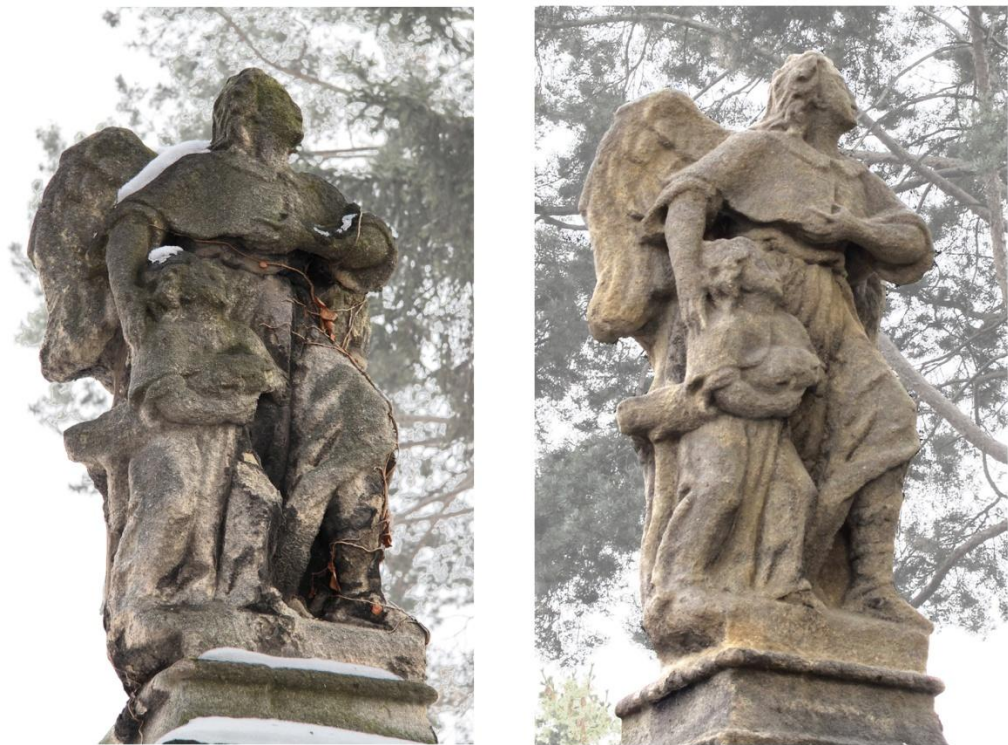
The CaLoSil® was tested and subsequently used with positive results for the conservation of the statue - *The angel with the child* from Kutná Hora. Nanosuspension was used for stone consolidation and grouting of this sculpture made from biodetritic coarse-grained limestone. An essential problem during the usage of nanosols for the sculpture consolidation was the white haze formation on the surface after the consolidation treatment. The tests of white haze removal were performed and so the white haze was finally removed by water vapour and abrasive cleaning methods. The final evaluation of consolidation effect was performed by means of drilling resistance and ultrasound velocity measurement. [13]

Figure 3. The statue The angel with the child. On the left picture there is the sculpture before the conservation treatment, on the right side the sculpture after the conservation treatment. Foto Dana Macounová.

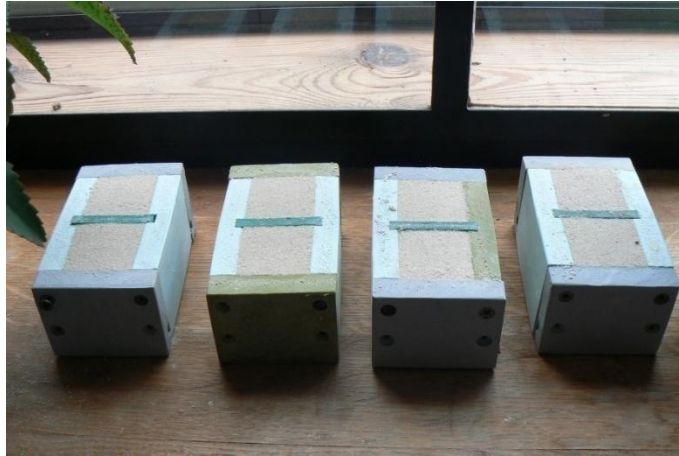
Figure 6. Prepared samples were drying in the moulds.

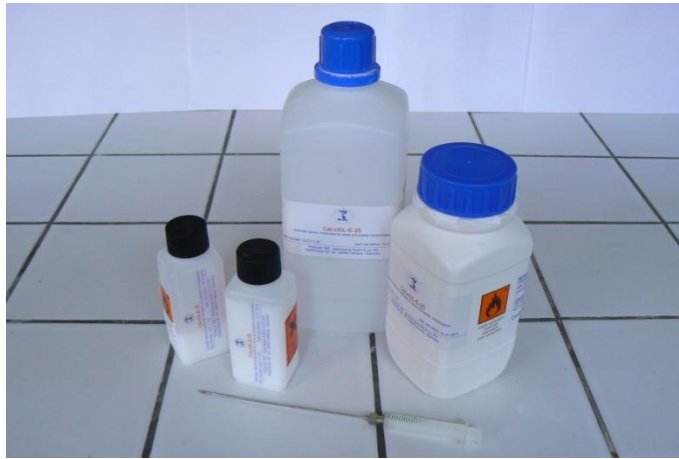
Each type of mortar substrates was treated by two different consolidants. For consolidation of specimens imitating highly corroded lime mortar the consolidant CaLoSiL® E25 was used. When the specimens imitating highly corroded gypsum mortar were consolidated the Sol CaSO₄-Ca(OH)₂ was applied. This gypsum sol contains 30 g/l of Ca(OH)₂ and 15 g/l of CaSO₄). Consolidants and its composition are given in Table 1, Figure 5.

Figure 8. Consolidants.

Type of specimen	Consolidant and its composition	Solvent
<i>Specimens imitating highly corroded lime mortar (NCLS)</i>	CaLoSiL® E25 – nanosuspension of Ca(OH) ₂ , (25g/l)	ethanol
<i>Specimens imitating highly corroded gypsum mortar (NCGS)</i>	Sol CaSO ₄ -Ca(OH) ₂ , (30g/l Ca(OH) ₂ + 15g/l Ca SO ₄)	isopropanol

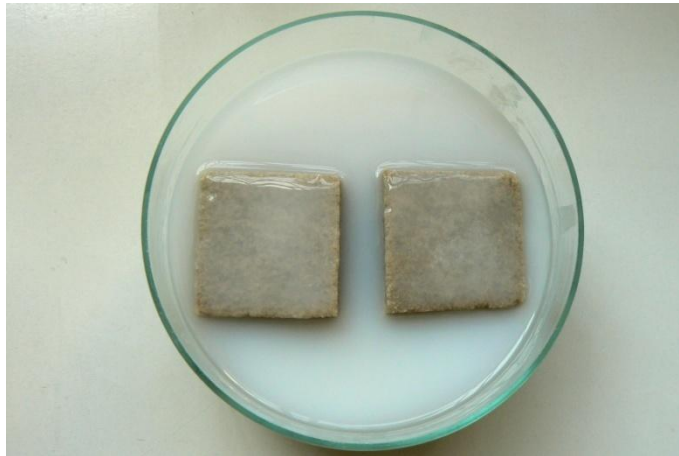
Figure 9. The gypsum substrates during consolidation by immersion in Sol $\text{CaSO}_4\text{-Ca(OH)}_2$.

each specimen. The Sol $\text{CaSO}_4\text{-Ca(OH)}_2$ was applied on gypsum mortar specimens (NCGS) in **3** cycles. This sol is more viscous and when the specimens were removed from the bath container after each consolidation cycle to get dry all the samples were covered by thick layer of liquid consolidant which did not drain from the surface completely (Fig.6, 7). After the each cycle the all samples were covered for one day by a slightly opened cover to avoid quick evaporation of ethanol. Next day the cover was removed and the specimens were exposed to laboratory conditions to get dry. The following application cycle was done when the specimens became completely dry. After drying the gypsum specimens were obviously covered by white layer of created crystals as the result of the viscous consolidant's residues trapped on the surface after the immersion process. All samples were weighted before and after each application.

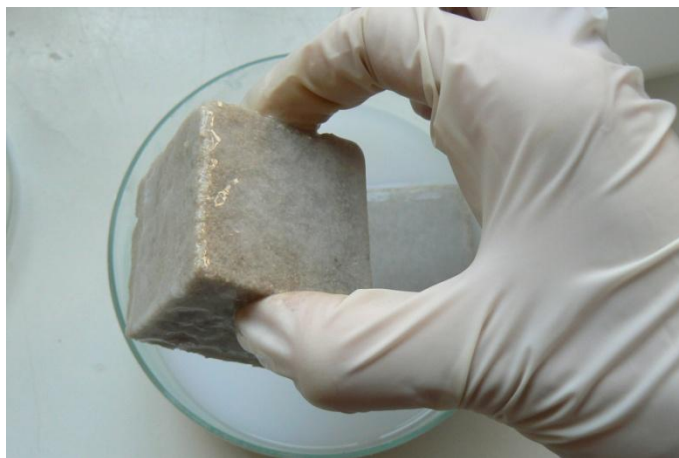
Figure 10. The gypsum substrate after removing from the consolidation bath.

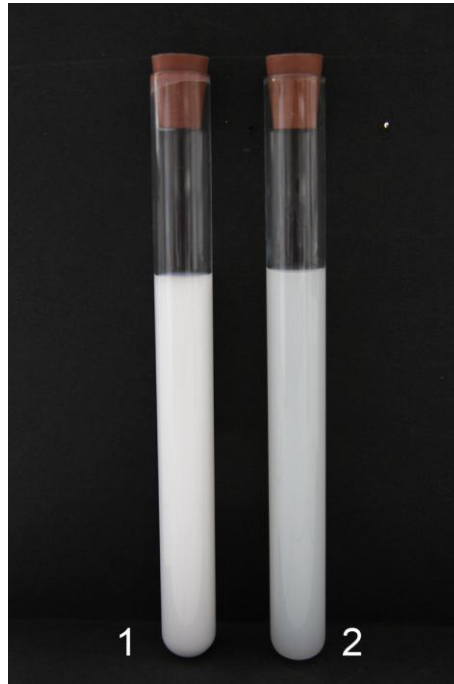
Three general characteristics of both types of consolidants are presented in Table 2. For comparison, the similar characteristics of pure solvent are labelled in the same table. These characteristics were obtained within the Stonecore project. Both consolidation systems are milky white liquids with low density around 0.8 g.cm^{-3} and with high surface tension very close to pure solvent. (Figure 11, Table 2)

Figure 11. Nanosuspension CaLoSil® E25 (1) and Sol CaSO₄-Ca(OH)₂ (2)

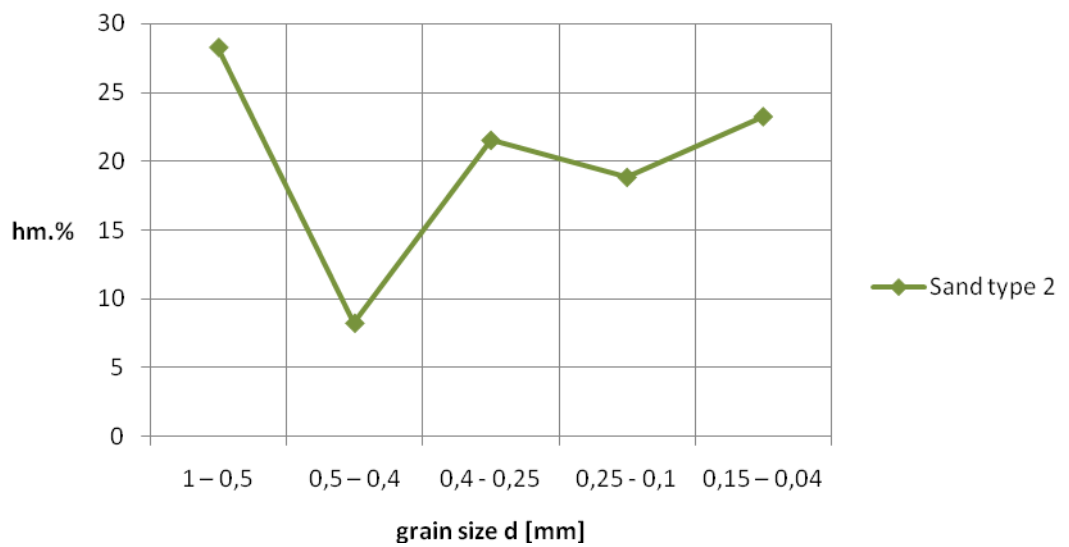
Figure 16. Particle size distribution of sand type 2.

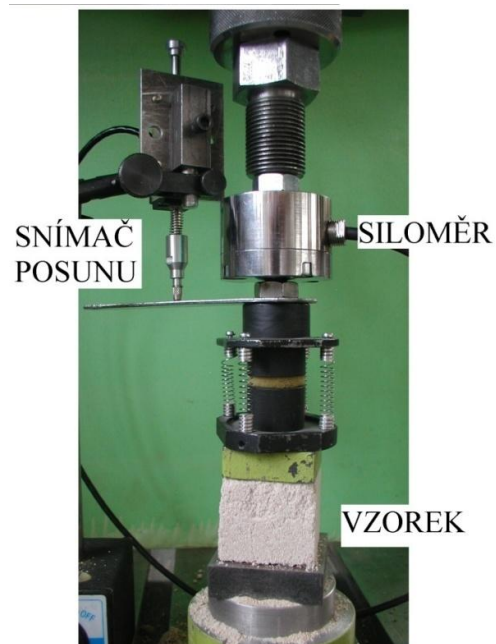
Figure 17. The compression strength testing device. The picture was made by ITAM AS CR v.v. i Prague.

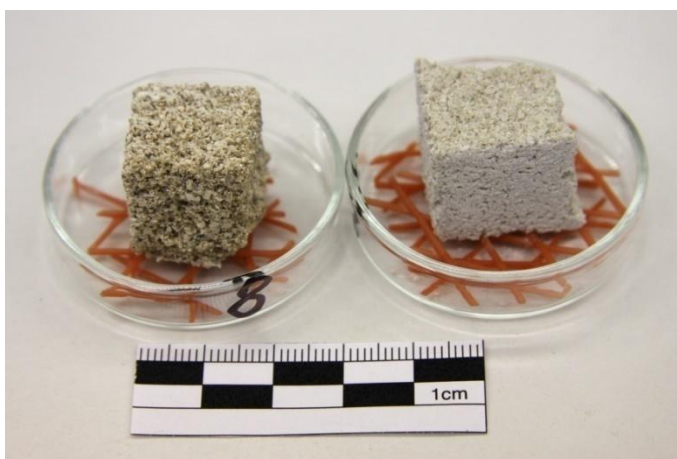
Figure 19. Specimens (cubes $2 \times 2 \times 2 \text{ cm}^3$) for water vapour adsorption test.

²⁶ Specimens were cut up from prepared substrates (4x4x4 cm) by small saw. The exact shape of these small cubes is not precise and regular. See on the Figure 15.

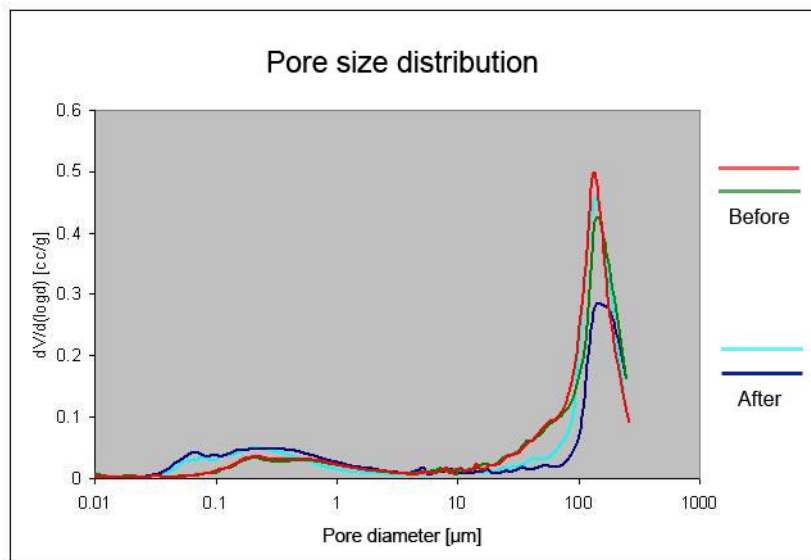
Figure 20. Differential volume of intruded mercury vs pore diameter for the lime specimens before (red and green lines) and after consolidation (light and dark blue lines).

Additional information on dimension and distribution of pores were obtained by pore size distribution measurement. Both types of untreated reference mortar samples (NCLS, NCGS) exhibit unimodal distribution of the pore dimensions characterized with sharp and well defined peak. In case of NCLS substrates the unimodal peak at 200 μm was observed and 100 μm for NCGS respectively. These pores can be defined as macro pores and are usually obtained in severely deteriorated substrates as a result of secondary weathering. After consolidation (light and dark blue lines), only marginal effect in pore size distribution can be observed. There is no change in pore size (similar peak position) but the slight decrease of the pore volume intruded can be observed. This is the result of the filling the pores by consolidant.

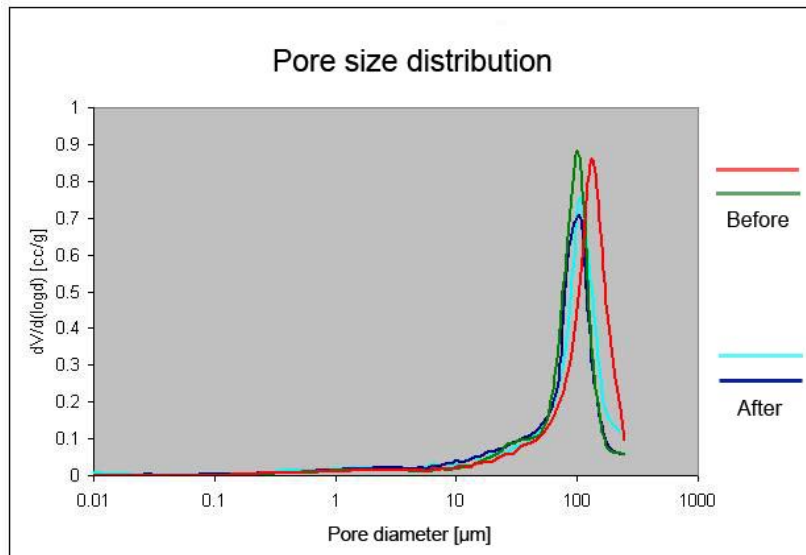
Figure 21. Differential volume of intruded mercury vs pore diameter for the gypsum specimens before (red and green lines) and after consolidation (light and dark blue lines).

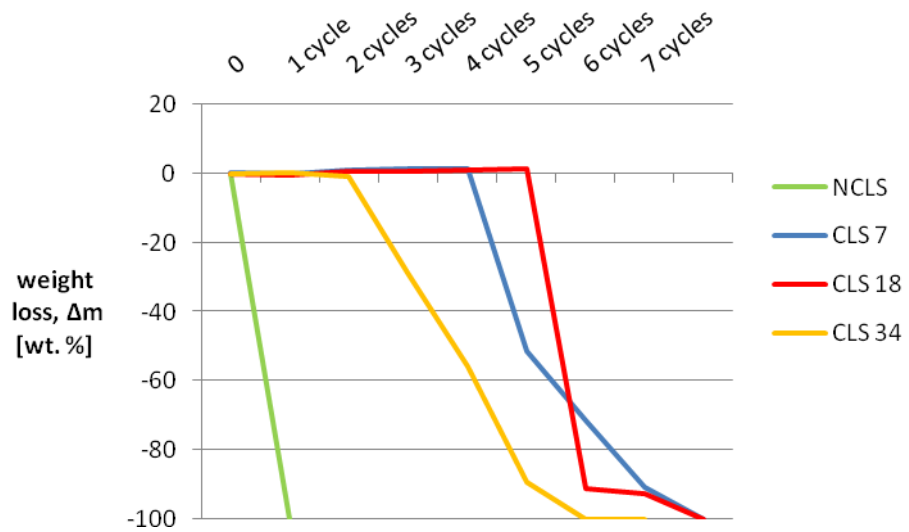
Figure 37. The weight change of not consolidated (NCLS) and consolidated lime substrates (CLS) during the freeze-thaw test.

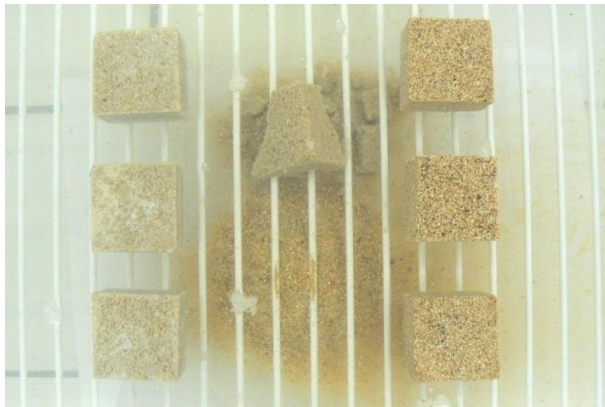
Figure 39. Specimens during 1st cycle of freeze-thaw test. Not consolidated substrates (in the middle) disintegrated immediately after immersion into the water container.

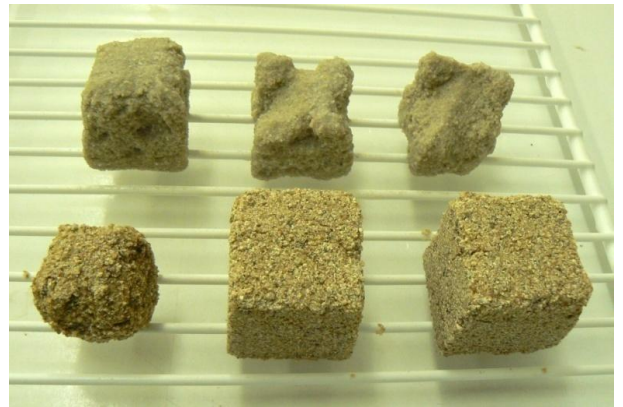
Figure 40. Specimens after 5th cycle of freeze-thaw test.

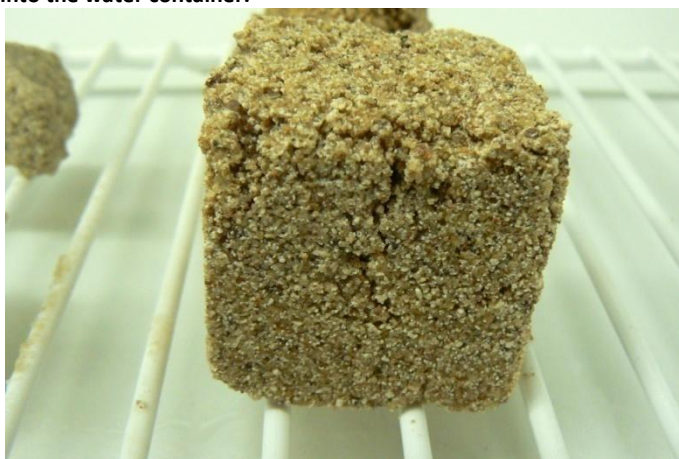
Figure 41. Cracking and rupturing of CLS specimen after 6th cycle of freeze-thaw test.

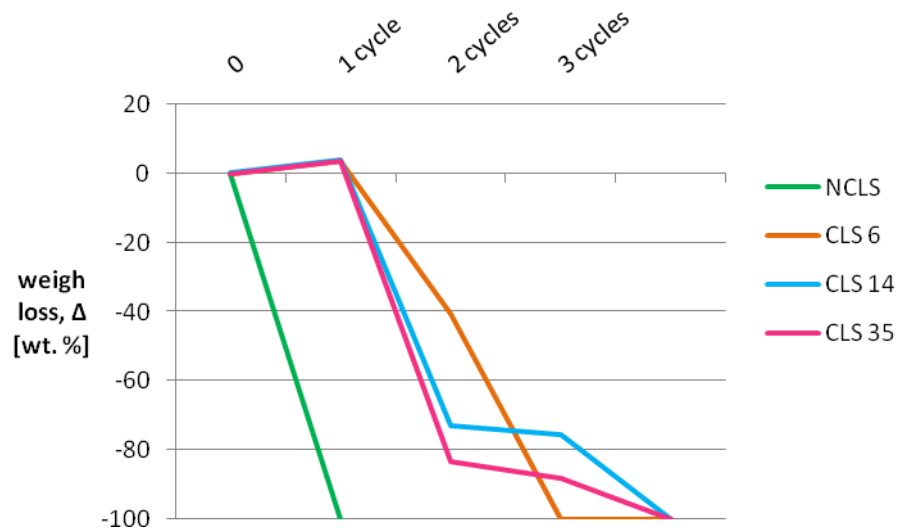
Figure 42. The weight change of not consolidated (NCLS) and consolidated lime substrates (CLS) during the salt crystallization test by immersion.

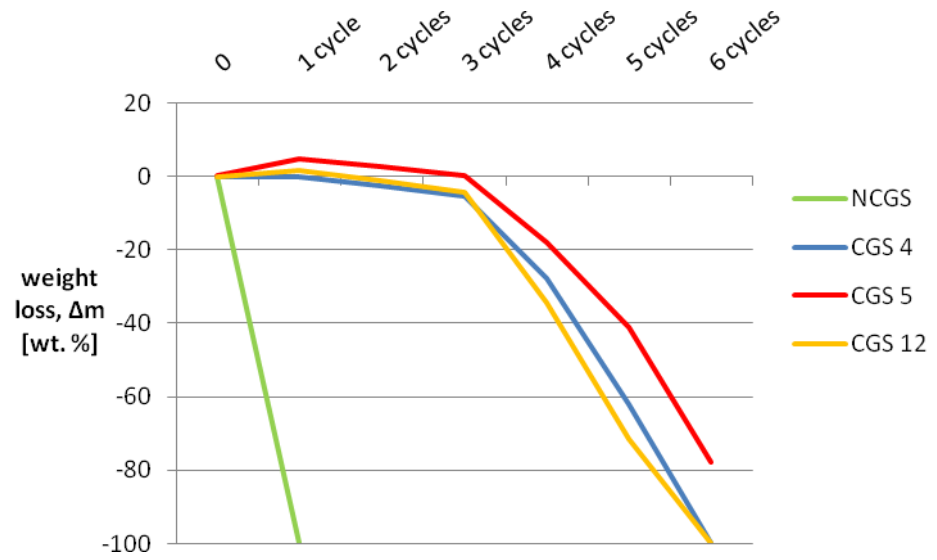
Figure 45. The weight change of not consolidated (NCGS) and consolidated (CGS) gypsum substrates during the salt crystallization test by capillary action.

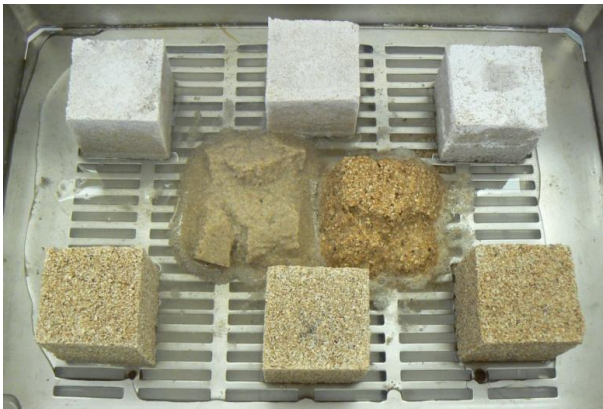
Figure 46. Specimens during 1st by capillary action. Not consolidated substrates (in the middle) disintegrated immediately in contact with salt solution.

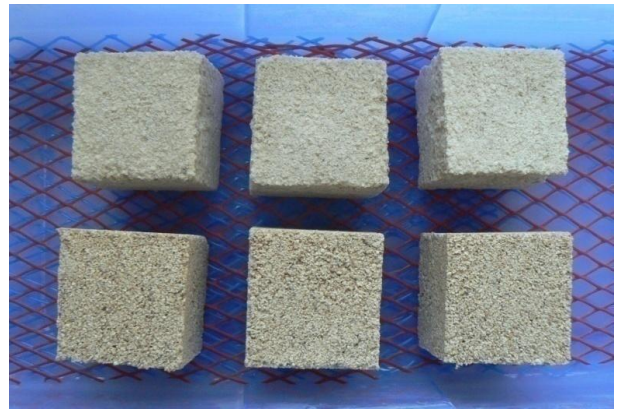
Figure 47. Salt crystallization test by immersion. The substrates after 1st cycle.

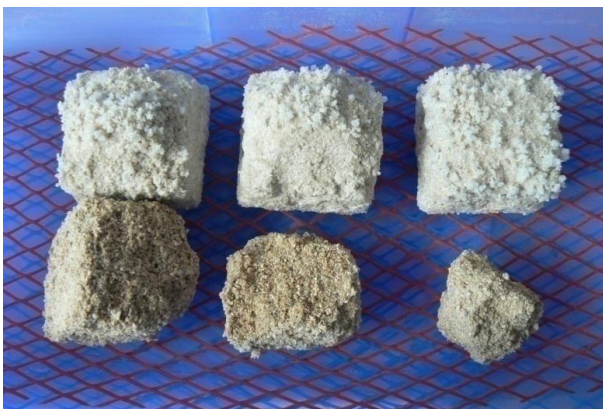
Figure 48. Salt crystallization test by immersion. The substrates after 2st cycle.

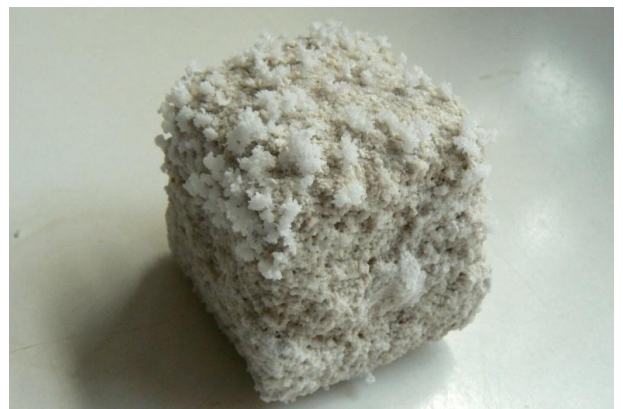
Figure 49. The formation of salt crystals on the top of the gypsum specimen. The substrate after 2st cycle of immersion.

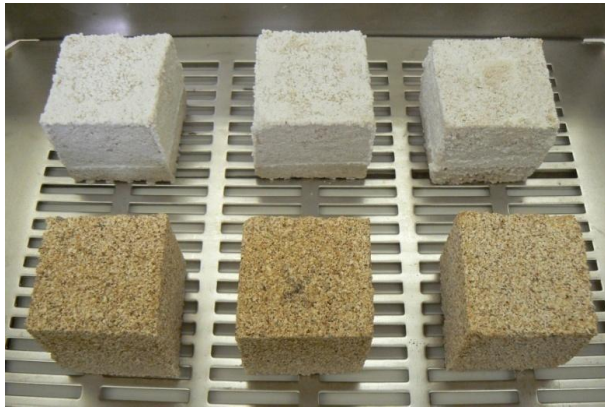
Figure 50. Salt crystallization test by capillary action. The substrates after 1st cycle. The white colour of gypsum specimens is caused due to the presence of small crystals layer on the surface.

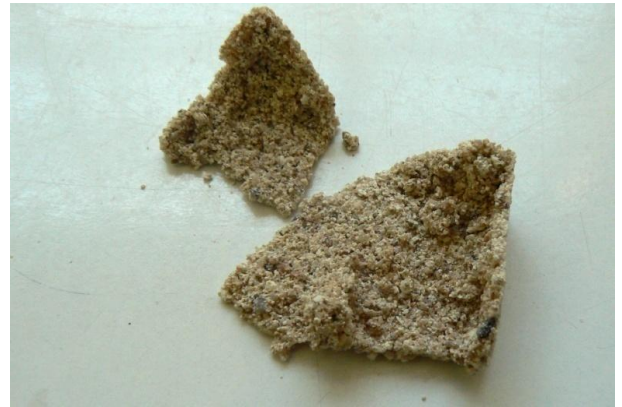
Figure 51. The crust created on the lime specimen. Salt crystallization test by capillary action. The substrate after 3th cycle.

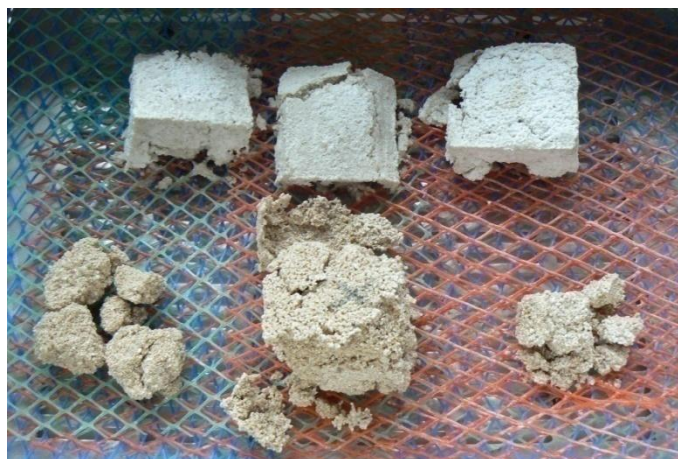
Figure 52. Salt crystallization test by capillary action. The substrates after 4th cycle.

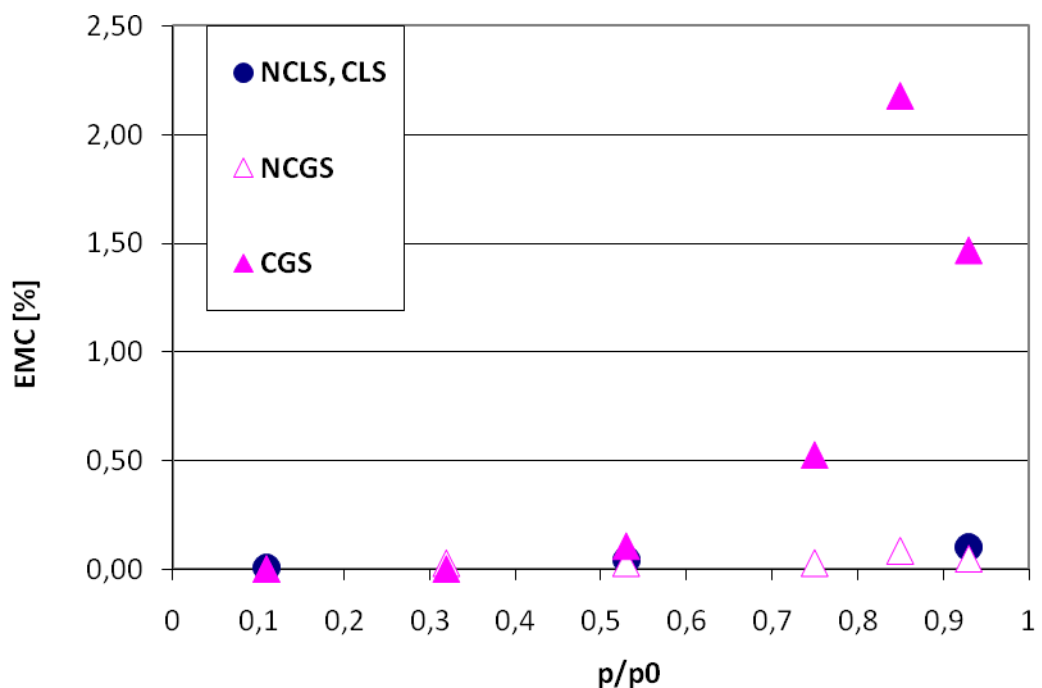
Figure 53. Equilibrium moisture content (EMC) of treated and untreated samples at different RH values (p/p_0).

Water adsorption test was performed to investigate moisture behaviour of samples before and after the consolidation. The test was divided into two parts: one set of samples were stored outside at atmospheric humid conditions (the samples were hidden from rain but exposed to the change of RH). The next set of samples were stored under the different RH conditions which were arranged by storing the samples in dessicators filled with different saturated salt solutions (in the range of 11-93 % RH).

hygroscopicity of gypsum component presented in the substrates. It is even more evident when samples after consolidation treatment (CGS) are studied due to their increased content of gypsum. The amount of absorbed water in gypsum consolidated samples (CGS) at 75% of RH is 0.5% and the maximum of water is absorbed 2.5% which is attained at RH around 90%. These findings limit the possible usage of tested gypsum consolidant on monuments exposed to external humid conditions. Such environment increases humid conditions in the substrate as well and can cause a migration of gypsum components to the surface and the formation of a rigid, more compact and less permeable layer.

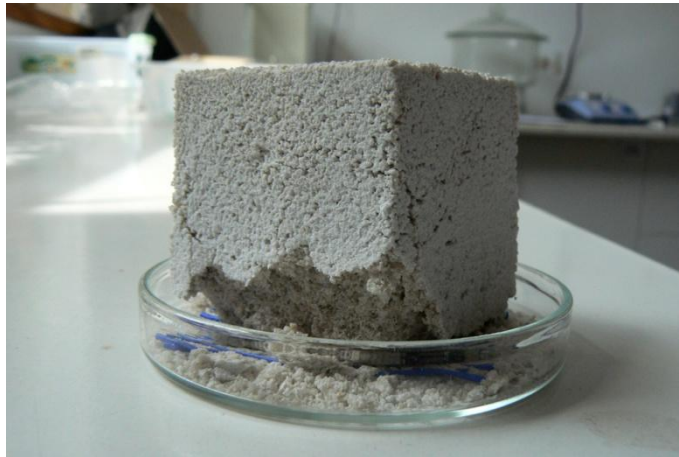
Figure 54. The substrate (CGS) after one week of the outside exposition.

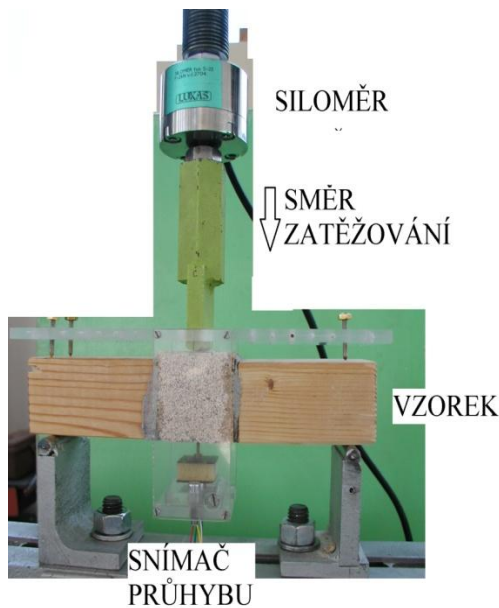
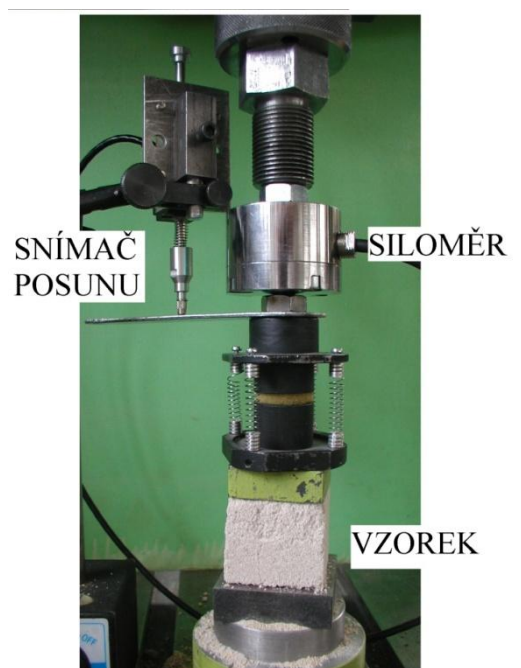
Schéma Stanovení pevnosti v prostém tlaku
