Conservational Case Studies from the Patan Royal Palace, Nepal

An International and Interdisciplinary Story

Marija Milchin – Gabriela Krist – Lisa Gräber

Universität für angewandte Kunst Wien, Institut für Konservierung und Restaurierung
University of Applied Arts Vienna, Institute of Conservation and Restoration

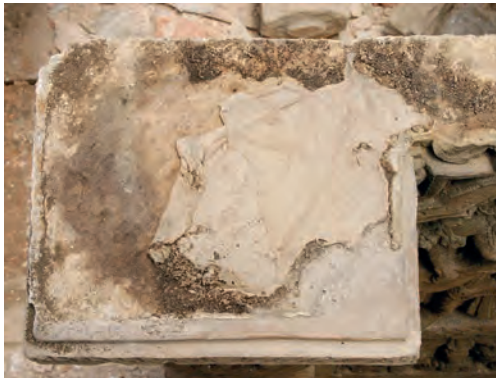
Fig. 1 (right) Patan, bio-colonization on one of the Mul Chowk lions. (Institute of Conservation, University of Applied Arts Vienna, 2011)

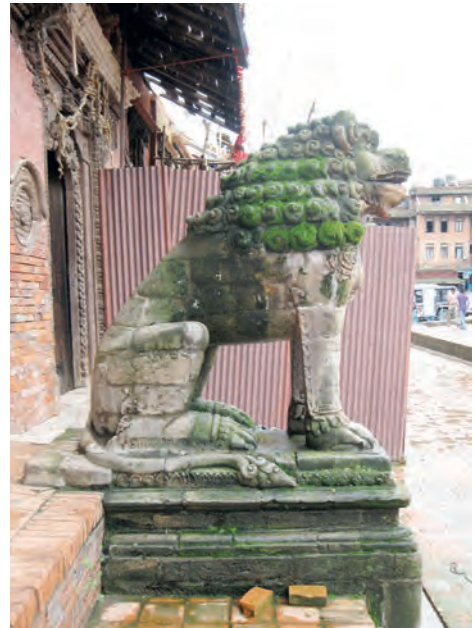
Figure 2 (bottom) Patan, insect nest in one of the joints of the Bhandarkhal Tank Pavilion. (Institute of Conservation, University of Applied Arts Vienna, 2010)

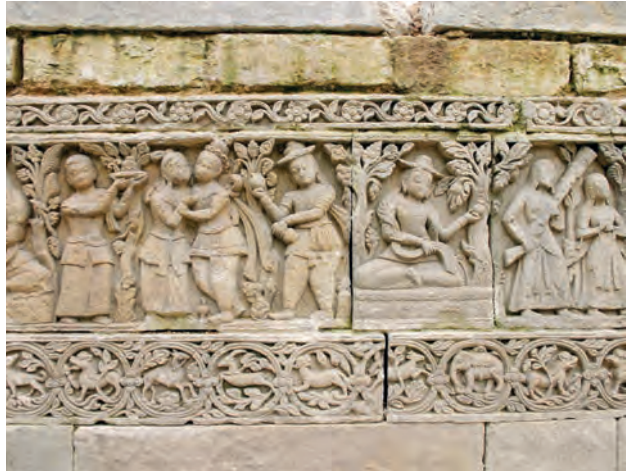
Fig. 3 Patan, Bhandarkhal Tank Pavilion, carving spreads regardless of the joint net. (Institute of Conservation, University of Applied Arts Vienna, 2010)

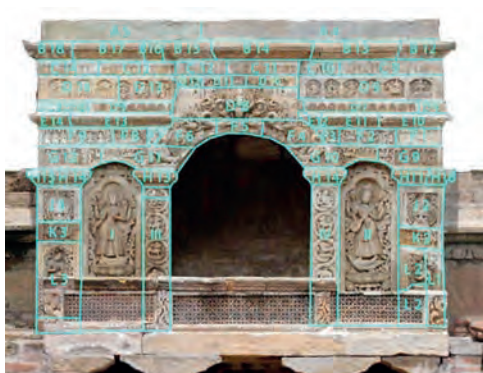
Fig. 6 (left) Patan, Bhandarkhal Tank Pavilion, graphic documentation of the blocks, their relative positions in the structure and the joint net, (Institute of Conservation, University of Applied Arts Vienna, 2010)

All elements were labeled and a plan was made with the positions marked. The next step was the dismantling. This was a very important part of the treatment. The joints that were still in their “original” state were very easy to open, since they did not have more than a couple of dashes of a natural resin. The portland cement paste, which was used mostly in the 1950s for repairs and reassembling, is where the problem usually starts. These joints are much harder than the surrounding stone and at the same time adhere very well to it. Therefore, it was very difficult to remove the mortar from the joints and leave the stone undamaged. In fact, it can be very complicated to crack the joint mortar whilst preventing the crack from spreading to the stone.²³

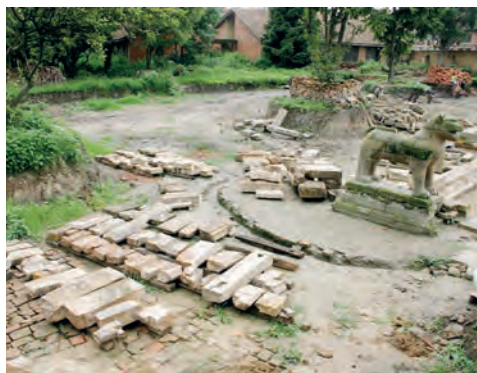
Fig. 7 (right) Patan, organization of the building site, the blocks of the Bhandarkhal Tank Pavilion after dismantling (Institute of Conservation, University of Applied Arts Vienna, 2010)

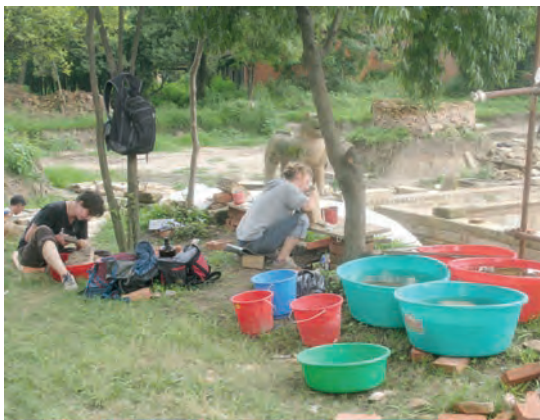
Fig. 8 (left) Patan, cleaning and water bath desalination, (Institute of Conservation, University of Applied Arts Vienna, 2010)

Blocks with obvious salt damage or those where strong salination was/is determined²⁶ are desalinated in a water bath. For this purpose we used ordinary plastic buckets. As tap water as well as the water from the Bhandarkhal Tank showed high anion concentrations (nitrates and chloride respectively), rain water (very low nitrate concentration) was collected and used for the desalination.²⁷

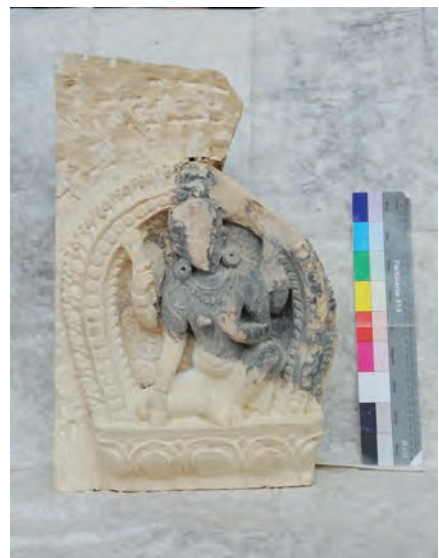
Fig. 9 (right) Patan, missing parts are being reconstructed by local stone masons/carvers, (Institute of Conservation, University of Applied Arts Vienna, 2012)

After the drying of the blocks, the broken parts can be glued together. This was done with a locally purchasable two-part epoxy resin. Reproductions of the missing parts were made by the Nepalese stone masons.²⁸ This proved to be a good solution, since the craftsmanship is still vividly present and of high quality in Nepal! It is not only important for the objects and this specific palace to make these reproductions. Projects such as this one also contribute to the preservation of traditional crafts, in the sense of intangible heritage. We in Europe know the problem of disappearing crafts as a consequence of industrialization only too well, so we were very happy to see that this was still not the case in Nepal. Minimal conservation without reproduction of missing parts would not only be ignorant of the different aesthetical expectations of the locals, but would also ignore the chance to contribute to the preservation of the immaterial heritage at the same time.

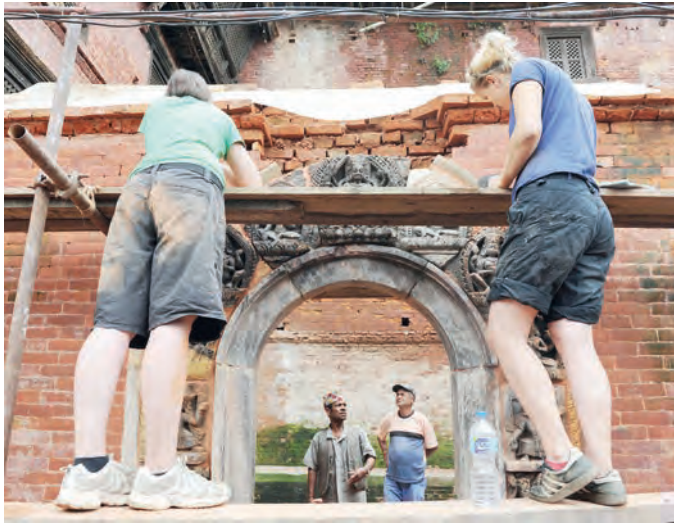
Fig. 10 Patan, reassembling of the stone gates. (Institute of Conservation, University of Applied Arts Vienna, 2012)

As a final step of the treatment, the elements were reassembled. This was done in a way that involved innovative steps that should repel water and give the structures greater stability against earthquakes. Where possible, the foundations were dried out,²⁹ the gates were reassembled without direct contact with the brick wall³⁰ and everywhere pins and clamps were used to stabilize the structures. For the joint pointing, we used a lime-brick dust mortar. This mortar seems to have some tradition in Kathmandu Valley. Even if it was not used for the original joints of the treated objects, the local craftsmen and workers seem to have experience with this recipe.³¹ The mortar also seems to have good properties as regards the climate and the stone material.

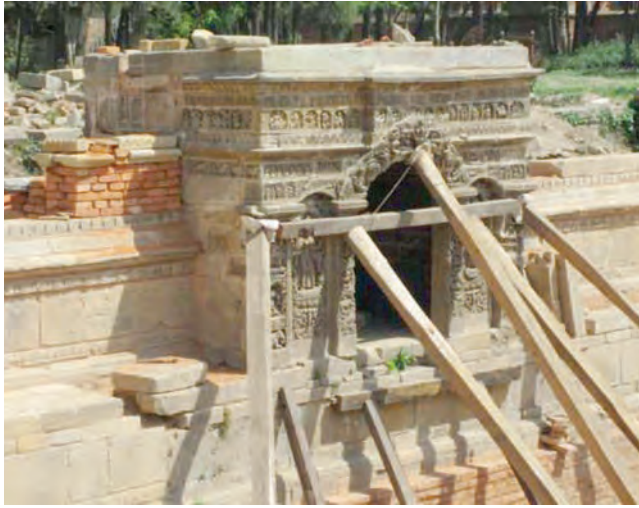
Figure 12. Patan, Bhandarkhal Tank Pavilion before the treatment, (Institute of Conservation, University of Applied Arts Vienna, 2010)

The base of the pavilion was partially reassembled after the great earthquake in 1934. The reconstruction happened sometime in the 1950s, but definitely before 1956. This was documented on the bricks used, on which “His Majesty King Mahendra 2013” (1956)³² was stamped before firing. The pavilion (its base) was therefore reassembled for the enthronement ceremony of King Mahendra which took place in 1956.³³ According to the Nepalese colleagues, portland cement first came to Nepal around 1950. This explains the rather inexperienced use of the material. The joints in the reassembled parts of the base were pointed with a portland cement paste with almost no aggregate. As mentioned earlier, there are good reasons to believe that an Italian team restored the base in the 1990s. The surface coating identified was probably applied as part of that treatment. The dense and hard joint filling in combination with the sealed and hydrophobic surface and the missing baldachin caused moisture to get trapped inside the stone. The water could penetrate through the foundation, as well as through cracks and the joints that remained without cement pointing (parts with original joints). This increased the damage due to salination and/or bio-colonization. The treatment of the base included documentation of the structure, mapping of the block borders, as well as marking of the single blocks. The dismantling process was the first practical cooperation between the Austrian and Nepalese teams. The next steps consisted of mechanical and chemical (acetone) cleaning, as well as biocide treatment and desalination. All of these conservation treatment procedures were carried out together with architects, craftsmen and workers from the Nepalese team. Finally, a brick dust-lime mortar and stainless steel pins were used to reassemble the base.³⁴ The concept for reassembling was determined cooperatively. The implementation of the practical work was done by the Nepalese team. The wooden baldachin was reconstructed by a local woodcarver. In addition, a new foundation was made and a pool foil was used to separate it from the rest of the structure. At present,

the capillary rise from the ground is interrupted by the foil and the stone base is protected against rain by the baldachin. The water that still manages to get into the structure, mostly in the monsoon season, can evaporate through the stone surfaces, but more importantly through the capillary active and hydrophilic joint mortar. Along with regular monitoring, a biocide treatment, especially for the lower portions that are dealing with splash water, has to be carried out after each monsoon.

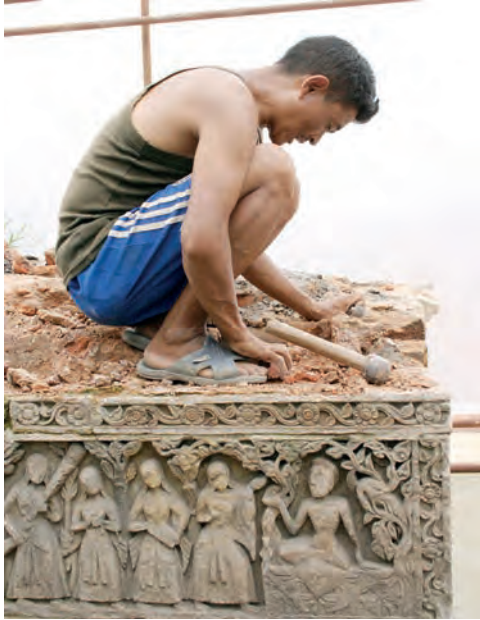
Fig. 13 (above left) Patan, dismantling the Bhandarkhal Tank Pavilion. (Institute of Conservation, University of Applied Arts Vienna, 2010)

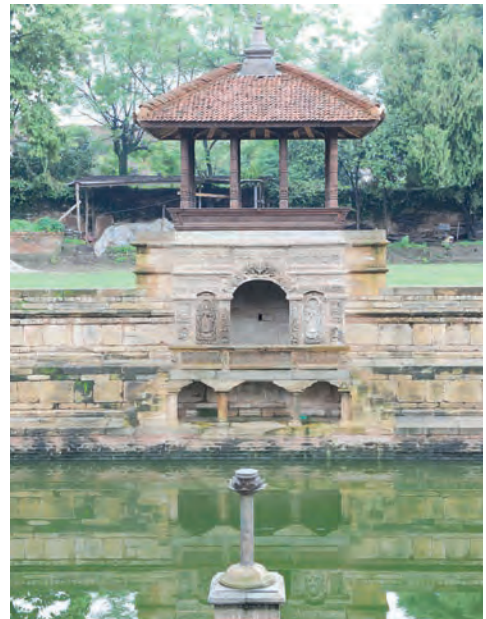
Fig. 15 Patan, the Bhandarkhal Tank Pavilion after the treatment and reconstruction of the baldachin, (Institute of Conservation, University of Applied Arts Vienna, 2011)

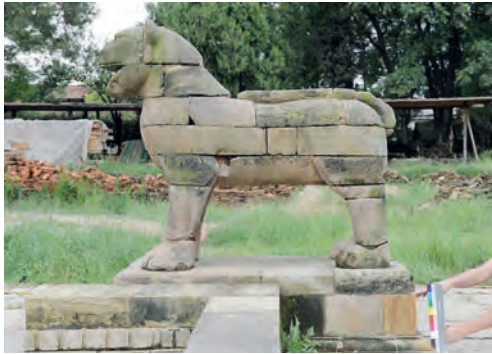
Fig. 16 Patan, a lion at the Bhandarkhal Tank before treatment. (Institute of Conservation, University of Applied Arts Vienna, 2011)

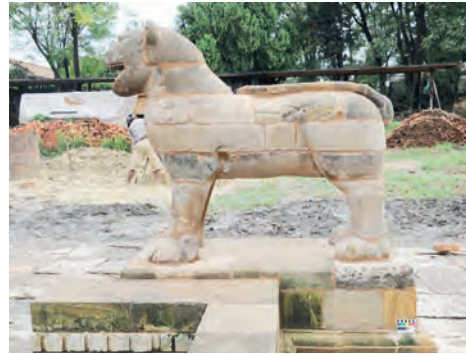
Fig. 17 Patan, a lion at the Bhandarkhal Tank after treatment. (Institute of Conservation, University of Applied Arts Vienna, 2011)

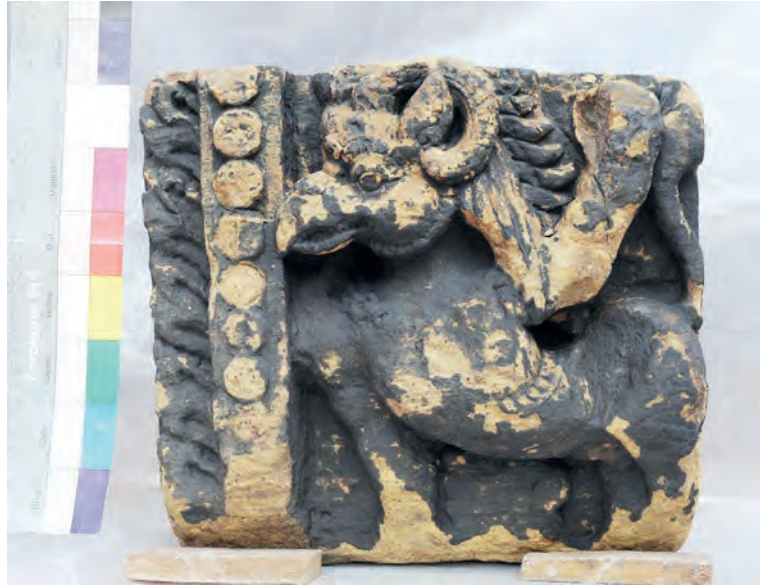
The gates showing Shakti goddesses on the front (square) façade of the Durbar Palace Complex were treated in the last campaign in 2012. Similar to the previously described objects, these ones were also reassembled after the earthquake of 1934 using portland cement paste with very little aggregate.³⁵ The only real difference to the other treated elements is a surface coating consisting of a bituminous substance. Alongside the sealing effect, which is comparable to the one caused on the pavilion base by the surface coating, the bituminous coating also affects the appearance of the gates.

Fig. 18 Patan, a fragment of the Stone Gates, the surface is covered with a coating consisting of bitumen. (Institute of Conservation, University of Applied Arts Vienna, 2012)

Once more the treatment included documentation, followed by dismantling, cleaning (mechanical and chemical with acetone), biocide and water bath for the desalination. Along with the stainless steel pins and the brick dust-lime mortar a gap between the stone blocks and the bricks behind them was established in the process of reassembling. After the summer campaign 2012, the gates were stabilized in their existing condition, but the appearance was not yet satisfactory.³⁶ The new parts, substitutions and joints were very light colored and the original blocks

from which the bitumen could only be partially removed still looked very dark. In order to find a solution to this problem a pre-thesis³⁷ was initiated. The results of the research demonstrated that there are two basic possibilities: to try to brighten up the appearance of the original stone, or to retouch – introduce a patina – to the new parts and joints. Due to the overall appearance of the previously restored parts of the palace, the second possibility was rejected. To brighten up the old parts further means to find a better solution for cleaning or to use color to paint over the surfaces.³⁸ There is objective reason to believe that the bitumen would creep through most colors and penetrate the new surface. We also wanted to leave the surface as permeable as possible. Therefore, further cleaning seemed to be the best possible solution. For this purpose trials with different solvents, with and without different light exposures (IR and UV) were done as part of the pre-thesis. All tests showed very similar results, and all of them were not much better than the results already achieved by the acetone cleaning in-situ.³⁹ In addition to the trials mentioned, laser cleaning was also undertaken. This gave very good results and was additionally

tested on the original surface⁴⁰ with great success.⁴¹ Since there is no laser available in Nepal, we are trying and hope to be able to arrange for this equipment for the project. The trials in retouching the surfaces also gave good results. Silicate based paint seems to meet the special needs (good adhesion and the bitumen does not creep through) in this situation.⁴² At the moment, small trial areas are applied in-situ in order to be able to evaluate these in the course of the summer campaign 2013.

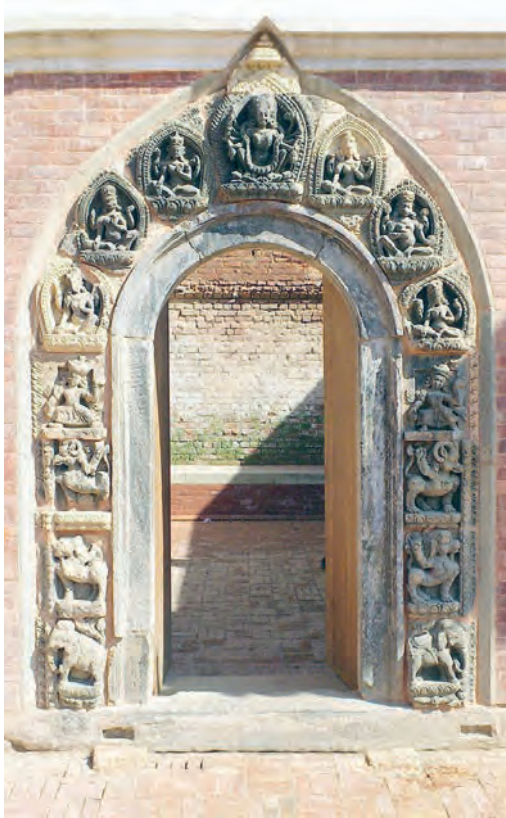
Fig. 19 Patan, Stone Gates after the treatment in 2012, new and old parts are very different in color. (Institute of Conservation, University of Applied Arts Vienna, 2013)
