Materials Used for the Conservation of Mural Paintings in Austria: Past – Present – Future

Robert Linke

Bundesdenkmalamt, Naturwissenschaftliches Labor, Wien
Federal Monuments Office, Natural Sciences Laboratory, Vienna

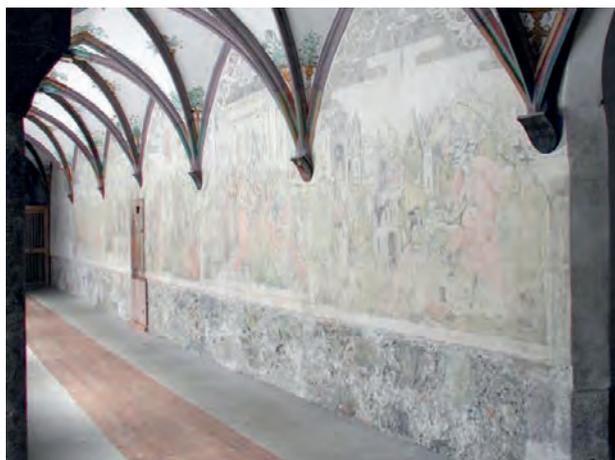
Fig. 1 Faded murals in the cloister of Schwarz in the Tyrol.

Written reports concerning the conservation and restoration of wall paintings are very scarce. Despite the existence of an enormous amount of undocumented treatments, there is an example found in the parish archive of Schwaz in the Tyrol. Extracts of the report by painters Georg and Andreas Höttinger, translated into English, are cited as follows: In 1652, father and son Höttinger restored the mural paintings from 1520 in the cloister of the Franciscan Abbey in Schwaz: “*Firstly, take a hot and highly concentrated base and wash the entire surface, additionally rub with soap, salt and straw. [...] As soon as the painting has dried, grind with a knife. [...] Afterwards rub with a cloth made of wool and nut oil. [...] Then lubricate the surface with egg white in order to improve the glossy appearance and to prevent the settlement of dust. [...]*”². According to the report, it is not surprising that nowadays the mentioned mural paintings are in a very poor condition as it can be seen in [Fig. 1]. Additionally, it should be mentioned that such a procedure was not the only torment mural paintings suffered from; treatments with wax and oil were also reported in the 19th century.

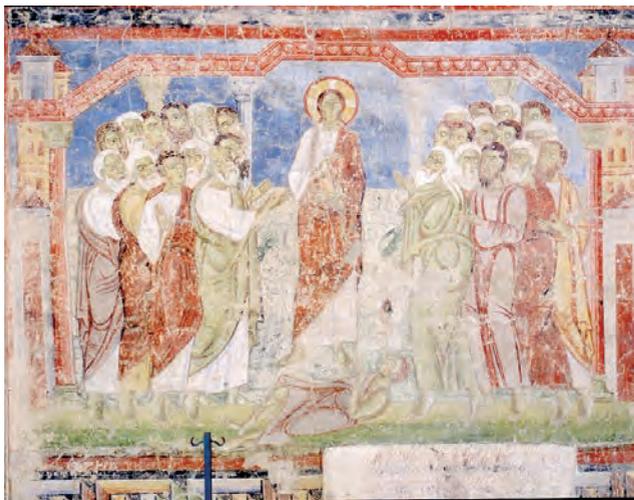
Fig. 2 (left) Mural paintings on the gallery of the collegiate church in Lambach. Foto: Bundesdenkmalamt Wien.

A number of early murals, dating from the time before the end of the baroque period, were covered with lime plaster, lime wash or lime painting due to their stylistic renovations. On the other hand, therefore the paintings were protected from any further harmful surface treatment. In Austria there exists only a very limited number of initially untreated lime paintings such as the paintings from the collegiate church in Lambach,¹⁶ Upper Austria [Figure 2], which were

discovered in the 1960s by conservator Franz Walliser. Another example from Austria, showing the initial brilliance of lime paintings, was found in 2006 in the roof truss of the Gozzoburg in Krems, Lower Austria [Figure 3].¹⁷

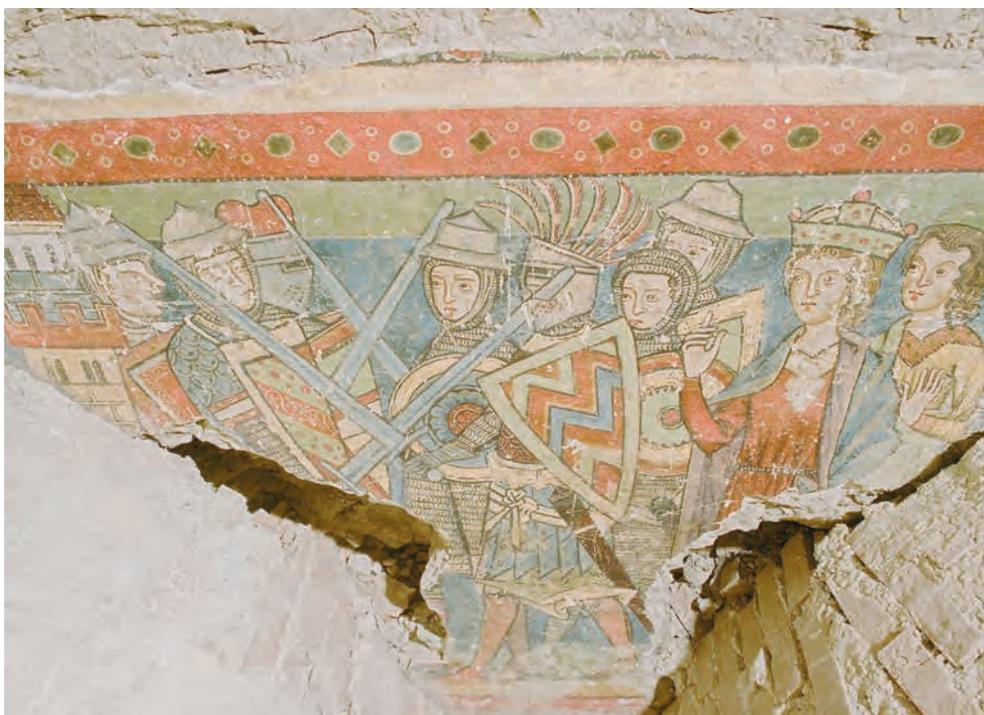
Fig. 3 (bottom) Recovered fragments of mural paintings in the fresco hall at the Gozzoburg in Krems.

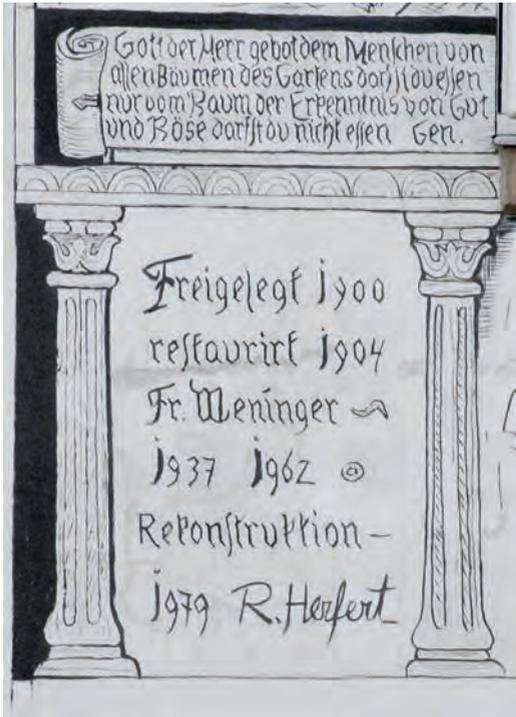
Fig. 4 Inscription on the Renaissance house from 1583.

Contemporaneously with the aforementioned methods of covering, from the second half of the 19th century on, a number of mural paintings were rediscovered. As a result of motivation increased by an exploratory urge and stoked by art historians, a number of murals were uncovered again and overpainted with inappropriate and irreversible binding media. Frequently, such treatments motivated by the spirit of the time, were connected to massive material loss. The inscription on a house in Horn (Lower Austria) with sgraffito decoration, built in 1583, which says “uncovered 1900, restored 1904 [...], 1937, 1962, reconstruction 1979 [...]” [Figure 4], could be regarded as a symbol of such a treatment of important monuments.

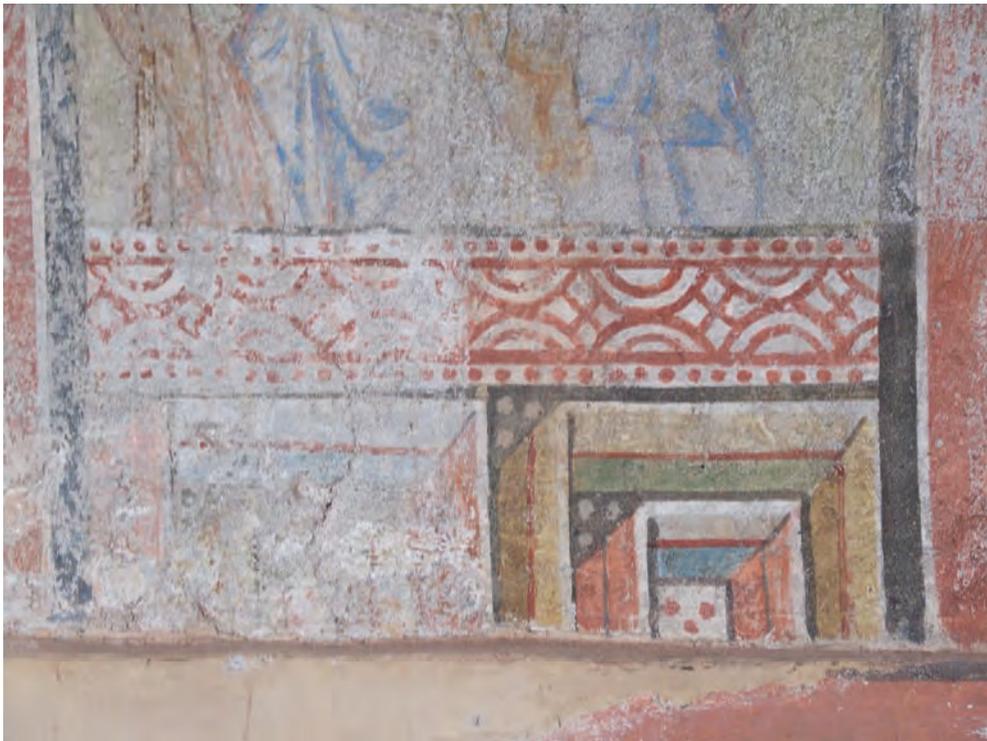
Fig. 5 (bottom) Campione of the initial overpainting at the St. John's chapel of Pürgg.

century can be found, such as the recently discovered murals from the Romanesque and Gothic periods, which were overpainted, including also completely new stylistic interpretations and even additions. Figure 5 shows a detail of a late Romanesque wall painting at the chapel of St. John in Pürgg (Styria), where a so-called campione on the right hand side gives an impression of a decoration of the 19th century. Theophil Melicher, one of the most employed artists of that time, carried out a number of conservation treatments in Austria and Bohemia using casein tempera, including Austria's most important murals in Thörl-Maglern, Maria Saal, Brixen, Hartberg, Millstatt etc.¹⁹. As we know today, such a technique not only changed the appearance of the original painting, but also increased the degradation processes due to mould infestation. In comparison, the area on the left hand side shows some residues of the original Romanesque paintings, which were preserved in 1947/48 by Franz Walliser.

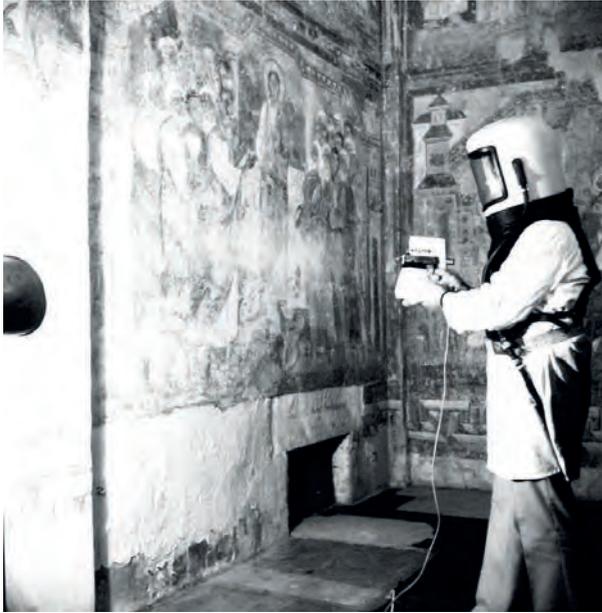
Fig. 6 Application of "Monumentique" on the mural paintings of Lambach in 1979. (Photo Bundesdenkmalamt)

Based on the experience with methyl silicate in the stone conservation in the 1960s, Austrian chemist Theodor Chavatal modified a product for the conservation of wall paintings and mortars. Dissolved in acetone, tetramethyl orthosilicate was sold as "Monumentique"^{24, 25}. The first applications and further development took place in the 1970s²⁶. Figure 6 shows the application of "Monumentique" in 1979 by spraying.
