# Appraisal of transport infrastructure for pedestrians in the city area, the case of Pardubice

**ABSTRACT:** *The paper is focused on pedestrian traffic in city area of Pardubice. Three localities are characterized in the first part of the paper. Each of them is illustrating one different problem of pedestrian transport. The first locality is a rush interchanging node of urban public transport located on both sides of a rush street. Problems related to passengers crossing this street by interchanging are highlighted. The second locality is representing a problem of decision between pedestrian level crossing or underpass. The third locality is representing a place with complicated interaction between transport participants (pedestrians and cyclists) in the case of limited spatial conditions. Unintuitive using of traffic marking and traffic signs is also mentioned. Proposed measures for improving of conditions in pedestrian transport are mentioned in local as well as general points of view. Second part of the paper is focused on conditions for pedestrians along one of the most frequented pedestrian routes in Pardubice. This route is connecting the main railway station and the city

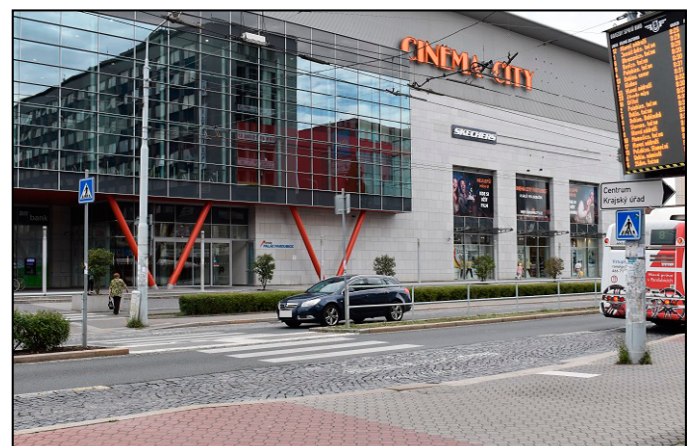
Surveyed marked pedestrian zebra-crossing is located in the middle of Masaryk Sq. It is a not signalized crossing nowadays (2017). This pedestrian crossing (Fig. 1) is also important for connection of the neighbouring shopping centre with the city centre. This is also an important part of intensity of pedestrian traffic flow (crossing the street here).

*Figure 1. Surveyed pedestrian not signalized zebra-crossing, Masaryk Sq. Source: photo authors.*

The number of 10 traffic accidents is registered (police investigated) here in 10.5 years long time frame (1 January 2007 – 1 July 2017) in UTM, (2017). 7 persons were light injured, 2 severe injured and 1 died. Each of these accidents represents 1 injured (in one case unfortunately died) person (especially pedestrian).

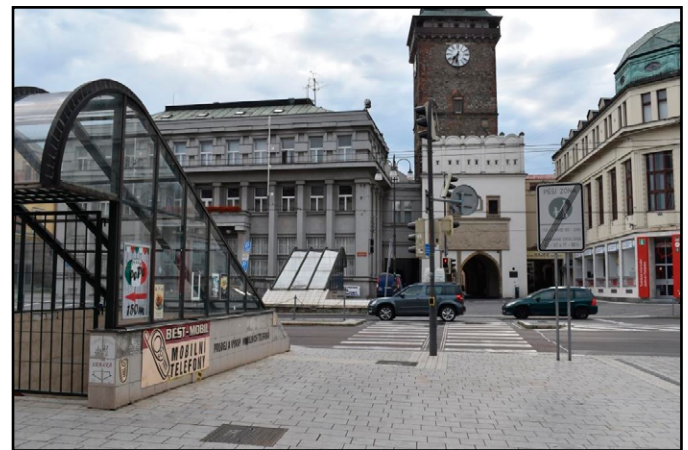
Second locality is signalized zebra-crossing (Fig. 2) located in the Square of Republic in front of historical Green Gate to the city centre. There is also a rush street consisted of 4 lanes separated by middle strip on northern side of crossing. Junction of streets Sq. of Republic and Míru St. is located directly on the southern side of this pedestrian crossing.

*Figure 2. Signalized zebra-crossing together with underpass, Sq. of Republic. Source: photo authors.*

4 accidents in connection to pedestrians are registered at this locality in 10.5 years long time frame (1 January 2007 – 1 July 2017) in UTVM, (2017). Each of these accidents causes 1 light injury (one person). Important fact is that 2 of these accidents were caused by pedestrians.

Historical development of this place represents important experience as well. This place is equipped by pedestrian underpass (subway). Construction of this underpass was started in 1971 and underpass was opened in 1973. Underpass was equipped by escalators. Demand after utilizing of this underpass decreased after setting escalators out of operation (in 90's years). Public demand caused, that this level pedestrian crossing has been realised as well. It was constructed as a not signalized pedestrian crossing. Crossing was equipped by car retarders to decrease speed of traffic. These retarders were removed due to negative influence of tremors on buildings in surroundings. Safety was improved by installation of traffic lights after replacement of retarders.

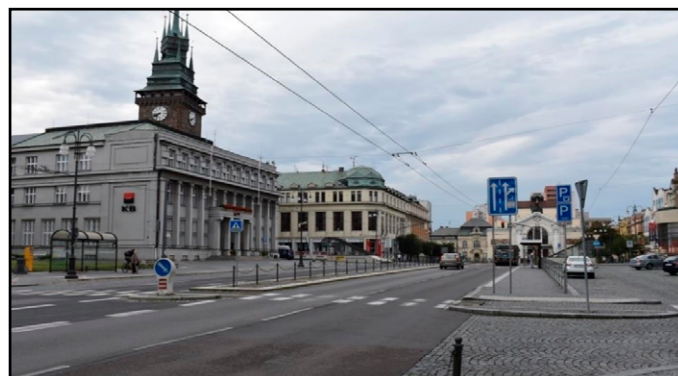
Illustration of view of approaching car driver is provided by the Fig. 3. Analysed signalized zebra-crossing is located in the ‘middle of picture’ (Fig. 3) behind a bus stop. Other pedestrian crossing (the 6<sup>th</sup> in order on Sukova St.) is located in forefront of the Fig. 3. It illustrates the problem with high density of crossings at this street as well. Commented parking lot with a way-out situated directly in front of (analysed) signalized zebra-crossing is placed on the right (way-in is in forefront).

**Figure 3. Signalized zebra-crossing (a view of approaching car driver), Sq. of Republic. Source: photo authors.**

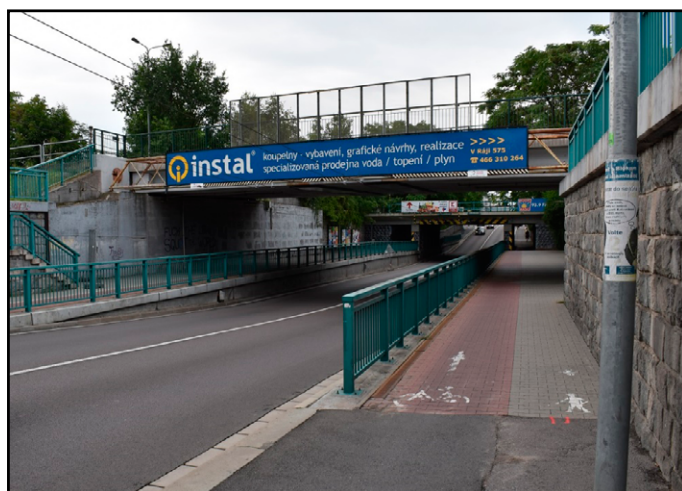
The street of '17 November St.' is led under a set of two bridges. These bridges are creating multilevel crossing with the street 'Hlaváčova St.' and the railway line Praha – Česká Třebová. Pavements (sidewalks) for pedestrian traffic are located at both sides of the 17 November St. in this area. Problem is, that each cycle track is realized as one-way lane for cyclists only due to limited space (Figure 4). Lanes for cyclists located on pavements are marked by a red colour of surface, pictograms of bike and arrows marking allowed direction of cyclists' ride. The problem occurred at this place is based in interaction between pedestrians and cyclists due to relative narrow space.

Figure 4. Segment of the 17 November St. Source: photo authors.

nificant and an adequate application of both of these signs can be helpful for orientation,. Example of this locality (compare Fig. 4 and 5) illustrates this.

- possibilities to infrastructure changes without serious construction works (investments) are limited, because spatial conditions are limited here,
- possible extension of width of pavements can be helpful, but it is not able to be realized without deep economic analysis of effectivity (it is related to high volume of construction works with serious demands on costs),
- lanes for cyclists are marked by different colour of surface now, so that it is not able to be proposed this as an improving measure,
- extension of lanes for cyclists to approaching area (towards city center) is not possible due to limited spatial conditions (lack of space for pedestrians, because lamp posts are placed in pedestrian lane), Fig. 4.

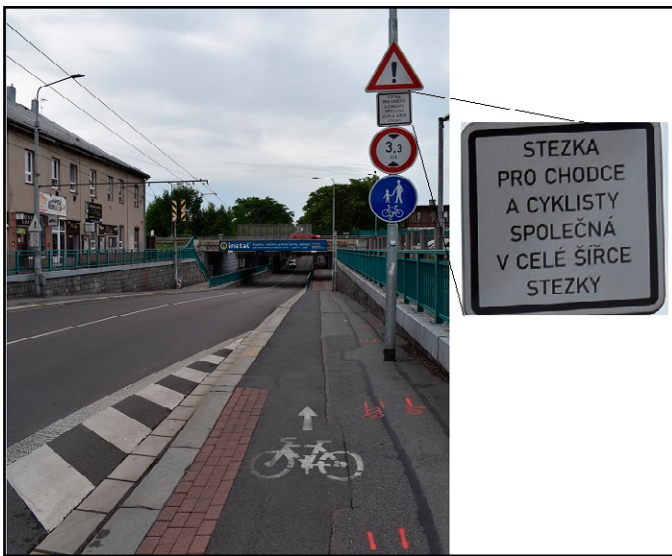
Last, but not least, problem at this locality is, that traffic marking is not too much intuitive here. The path in entering area is declared as 'collective lane' with no spatial division due to narrow space in entering area of this locality and two lamp posts located in a 'pedestrian part'. It is marked by vertical traffic sign No. C 9a and it is also highlighted by traffic sign No. A 22 'Other danger' equipped by the text 'Path for pedestrians and cyclists is collective in the whole width of path' (detail, Fig. 5). It is correct, for entering area. Under the bridges there is a 'divided path' for cyclists and pedestrians marked by the horizontal traffic marking only. Vertical traffic sign No. C 10a for 'divided path' is missing there. Due to the fact, that vertical signs are prior and no junction is located between these two places, pedestrians and also cyclists can become uncertain if the horizontal marking applied under the bridges separating cycle and pedestrian lanes is valid or not. Situation is visible in the Fig. 5. The authors are sure, that different meaning of both signs C 9a (divided path) and C 10a (collective path) is sig-

**Figure 5. Traffic signs, 17 November Street. Source: photo authors.**

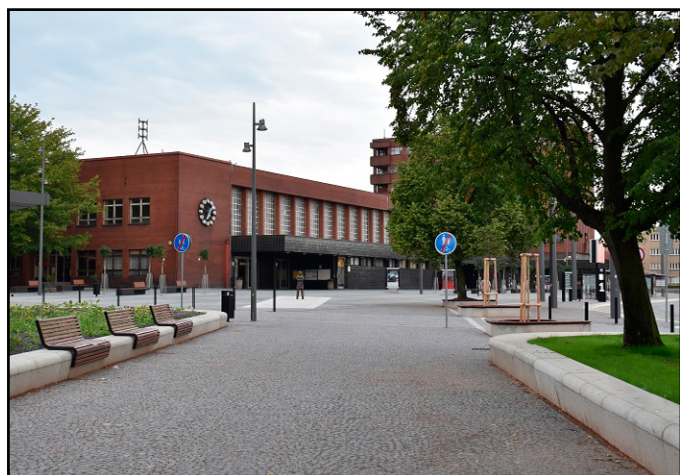
Second problematic fact, which is remaining, is a frequented movement of cyclists going to stands (and tower) for bicycles located in south-eastern part of the Jan Perner Sq. These cyclists are crossing basic pedestrian route to Palackého St. (towards city centre). This intersection is not able to be replaced. New solution of infrastructure allows relative more intuitive and clearly using of it, due to raised grass areas upon the level of pavements (Fig. 6).

**Figure 6. Reconstructed access to the railway station, Jan Perner Sq. (photo towards railway station). Source: photo authors.**

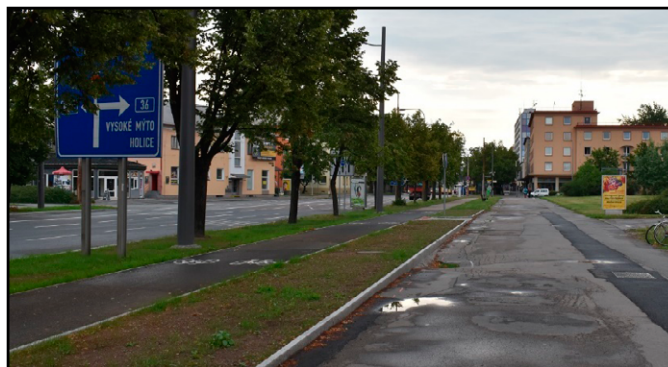
The rest of this segment is copying a car road of Palackého St. Traffic on this street is relative rush, because this is a part a route I/36 as well. Route I/36 is a trunk car road in relation east-west in Pardubice. Configuration of this route segment is visible in Fig. 7.

**Figure 7. Route segment the main station – Hlaváčova St., a part of Palackého St.. Source: photo authors.**

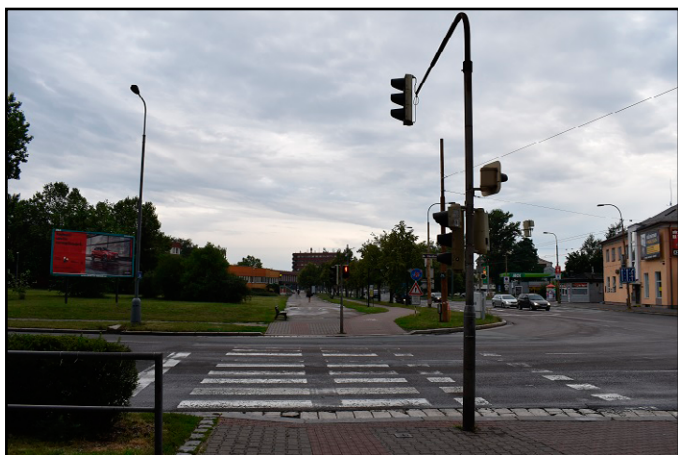
Relative long interval of traffic lights and smoking of pedestrians in groups of people waiting in front the crossing in the case of red signal are problematic. On the other hand, waiting of pedestrians in front of the crossing can be more comfortable due to a bench installed here (Fig. 8).

**Figure 8.** Signalized pedestrian crossing Hlaváčova St. (photo towards railway station). Source: photo authors.

Interval between green signals for pedestrians was irregular with average length of 100 seconds. The length of green signal is 10 seconds. Average waiting time for pedestrians walking towards the city centre was 45 seconds and towards railway station 40 seconds. Overview of results is provided by the Table 3. It can be seen on these values, that average waiting times are going to a half of duration of red signal. It can be explained in the way, that pedestrians are coming randomly and independently. Random access of pedestrians is presupposed by application of proposed modification of temporal crossing compliance rate *MTCCR*, see formula (1). Table 3 is providing additional characteristics useful for consideration of pedestrian traffic flow passing this crossing.

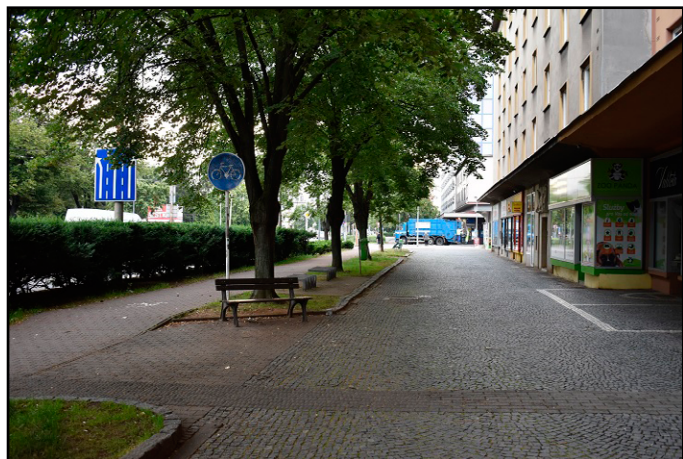
ment belongs also to Palackého St., but route I/36 is diverted now to Hlaváčova St. and the car traffic has city character (transit and freight transport are quite reduced here). Street is also important for urban and regional bus public transport. This segment is interesting by relative high number of obstacles for pedestrians created especially by mobile advertising stands of shops. There is the highest density of obstacles from all the surveyed route segments (2.33 obstacles/50 m).

**Figure 9.** Route segment Hlaváčova St. – Macanova St.  
Source: photo authors.

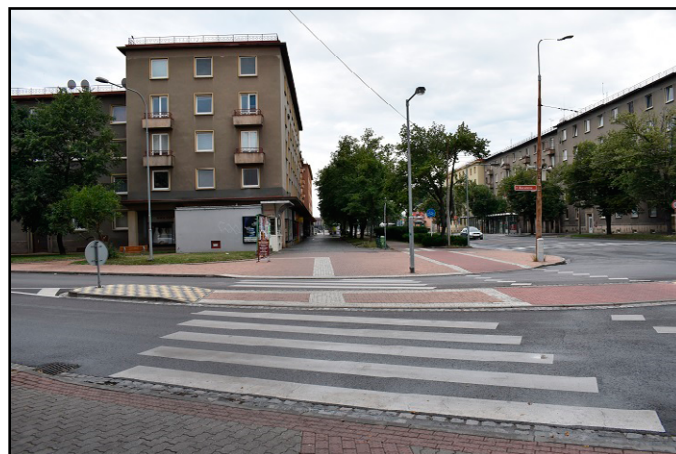
street, incl. a pedestrian crossing, is newly reconstructed. The pedestrian crossing is divided into 2 parts for each direction of car drive since this reconstruction (Fig. 10). Pedestrian crossing is equipped by a crossing for cyclists.

**Figure 10.** Not signalized pedestrian crossing Macanova St. (photo towards railway station). Source: photo authors.

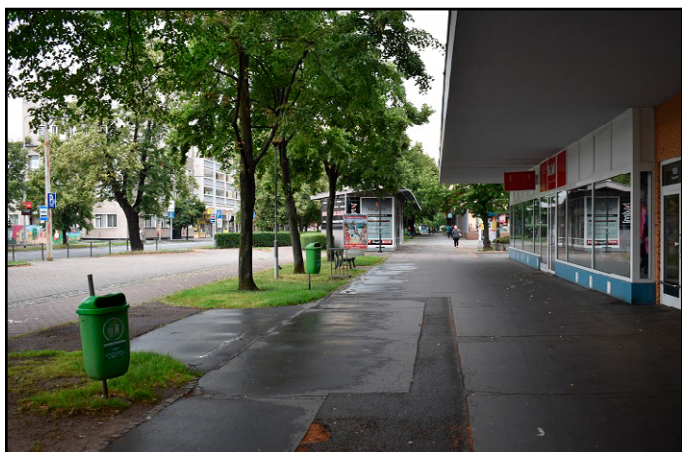
This route is similar like the segment between Hlaváčova and Macanova St. Difference is in the fact, that this segment is created by 2 blocks of flats. The surface is asphalt in front of the first block of flats and cobblestones in front of the second block of flats. An advantage is that the first part is partially covered by a block of flats, that pedestrians can be partially protected against rain (Fig. 11).

**Figure 11.** Route segment *Macanova St. – Havlíčkova St.*  
*Source: photo authors.*

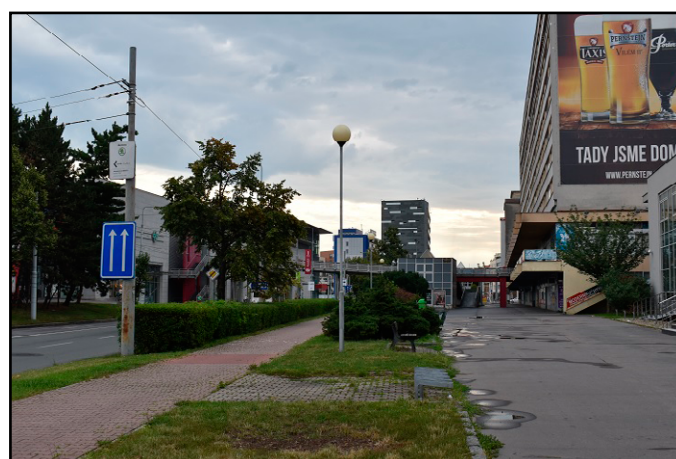
**Figure 13.** Route segment *Havlíčkova St. – 17 November St., the 1<sup>st</sup> part.*  
*Source: photo authors.*

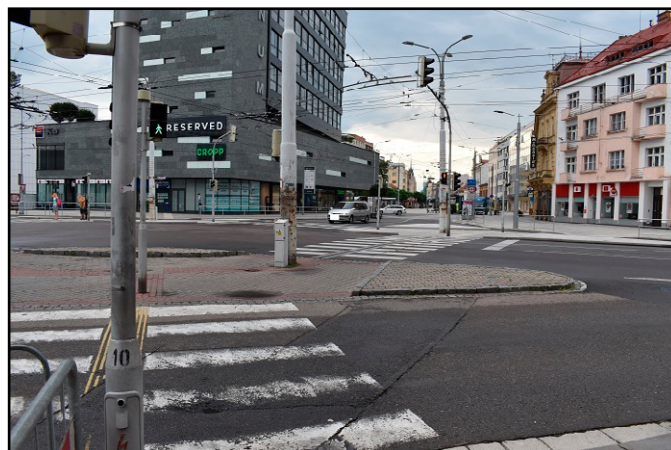
**Figure 15. Set of 3 pedestrian crossings (17 November St.)**  
Source: photo authors.

Signalized junction of streets Palackého, Míru, 17 November and Masaryk Sq. is a junction of two main roads of the CBD. Pedestrian route from the main railway station to the city centre is crossing the 17 November street by a set of 3 subsequent pedestrian crossings. First two are signalized, the third not. The third crossing is over the road connected to a pedestrian zone and used especially by limited number of trolleybuses only. This set of pedestrian crossings is in the Fig. 15.

Basic features of this set of 3 pedestrian crossings are mentioned in the Tab. 9. Crossings are numbered in order from the main railway station to the city centre (crossing No. 1 is located in forefront in the Fig. 15, crossing No. 3 in forefront in the Fig. 16).

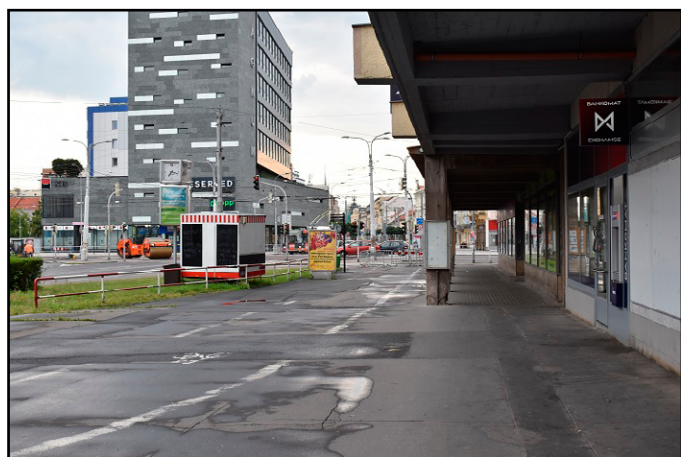
Part of segment with lane for cyclists marked at pavement close to the junction with 17 November street is in the Fig. 14.

**Figure 14. Route segment Havlíčkova St. – 17 November St., the 2<sup>nd</sup> part equipped by the lane for cyclists.**  
Source: photo authors.

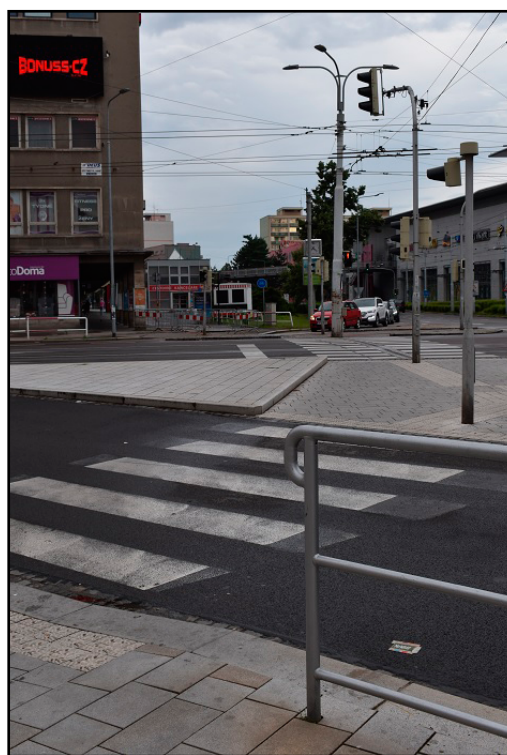
**Figure 16. Set of 3 pedestrian crossings (17 November St.), reverse view towards railway station.** Source: photo authors.

Pedestrians walking towards the city centre will wait between signalized crossings No. 1 and No. 2 for 7 seconds, in other direction towards railway station for 30 seconds.

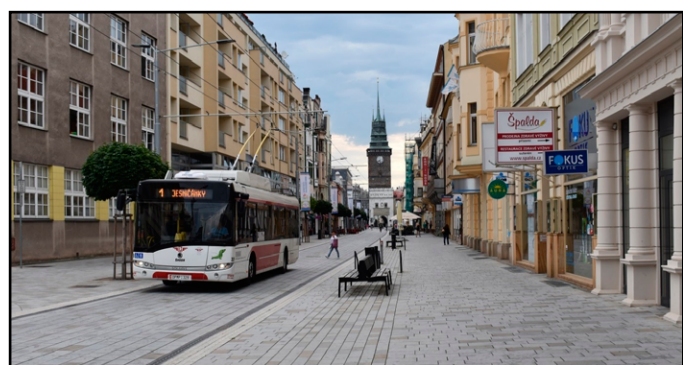
St. branching to the south (right) in the point of this appraisal. On the other hand, the first two segments have the same conception – it is a pedestrian shopping street by relative width pavements and relative narrow road (for trolleybuses, cyclists and cars with permission only). Cars supplying shops or other objects can enter in limited time frame only. Pavements and the road are on the same level, so that no raised kerbs are used here. This solution allows pedestrian flows to use also the route (if a trolleybus is not going). The way of operation is illustrated by Fig. 17.

**Figure 17. Traffic organization in Míru St. (middle route segment Sladkovského St. – Jindřišská St.). Source: photo authors.**

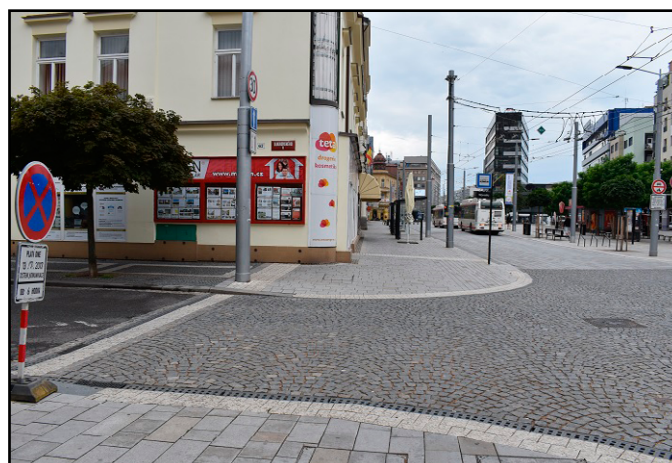
It is necessary to cross three roads by passing on appraised pedestrian route in the locality of Míru St. These crossings are marked as place for crossing (not a zebra-crossing). The first is Sladkovského St. (Fig. 18). This street is used especially by cars accessing Sladkovského St. in direction from north to south. This traffic is almost local, terminating in the areas located southern of Míru St. The length of the crossing is 6 m.

**Figure 18.** Place for crossing Sladkovského St. (photo towards railway station). Source: photo authors.

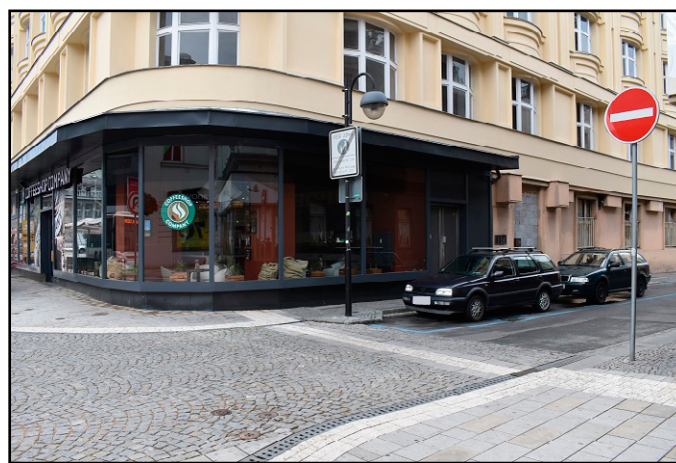
The second street needed to be crossed is Jindřišská St. (Fig. 19). This street is accompanying car traffic from neighbouring area to Míru St. These cars are continuing towards the Sq. of Republic. The volume of this traffic is no problem at the place for crossing. The length of the crossing is 6 m.

**Figure 19.** Place for crossing Jindřišská St. Source: photo authors.

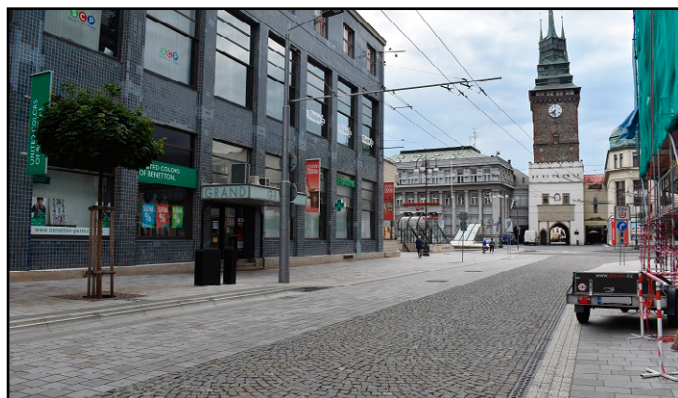
The last place for crossing is the road of Míru St. itself (Fig. 20) with width of 7 m. Signalized pedestrian crossing at the Sq. of Republic (mentioned in also in chapter 6.2.) is located on the left side of Míru St. Crossing on the right side is not possible.

**Figure 20.** Place for crossing Míru St. Source: photo authors.
