Effectiveness of structural walls in improving the serviceability of a seismically-retrofitted RC building

Ahmet Şimşek¹ · Özgür Yurdakul² · Burak Duran³ · Onur Tunaboyu¹ · Suat Yıldırım⁴ · Özgür Avşar¹

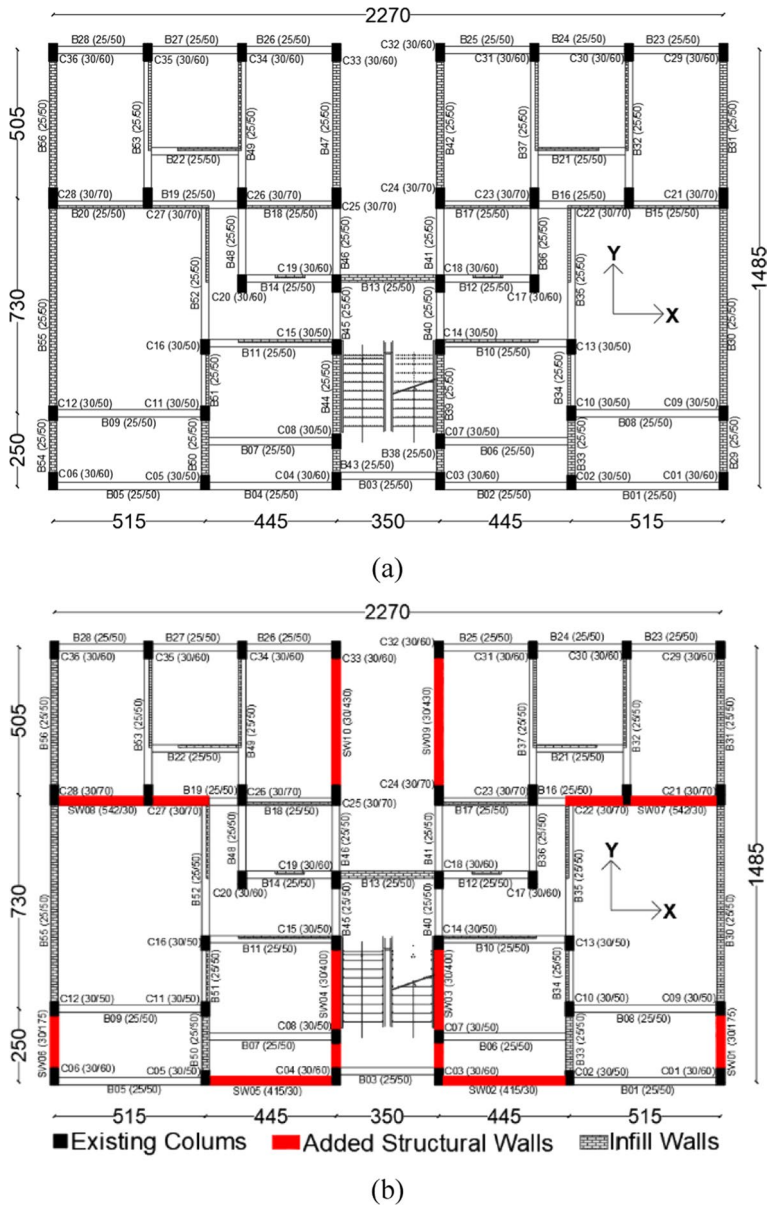
Fig. 4 Floor plan of investigated buildings **a** non-retrofitted **b** retrofitted (units are in [cm])

The floor plans of the investigated buildings in this study are given in Fig. 4a, b. Structural intervention with the addition of the structural walls during the period of 2011–2015 was carried out on the retrofitted residential building. The building that is under the control of another administrative unit was not subject to any structural intervention and remained untouched. The concrete and steel grades used in the additional structural walls of the retrofitted buildings are C25 and S420, respectively. Structural walls were placed in the most symmetrical way as possible, as shown in Fig. 4b.
